**Date: January 31, 2024**

**To: City of Riviera Beach Building Department**  
600 West Blue Heron Blvd, @214C  
Riviera Beach, FL 33404

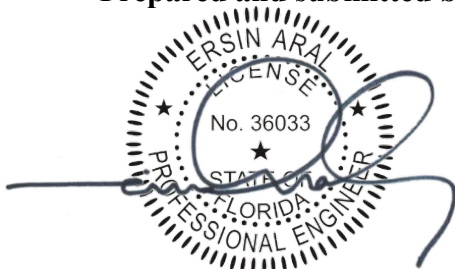
**Ersin (Eric) Aral,  
P.E. #36033, S.I. #599** 1/31/2024

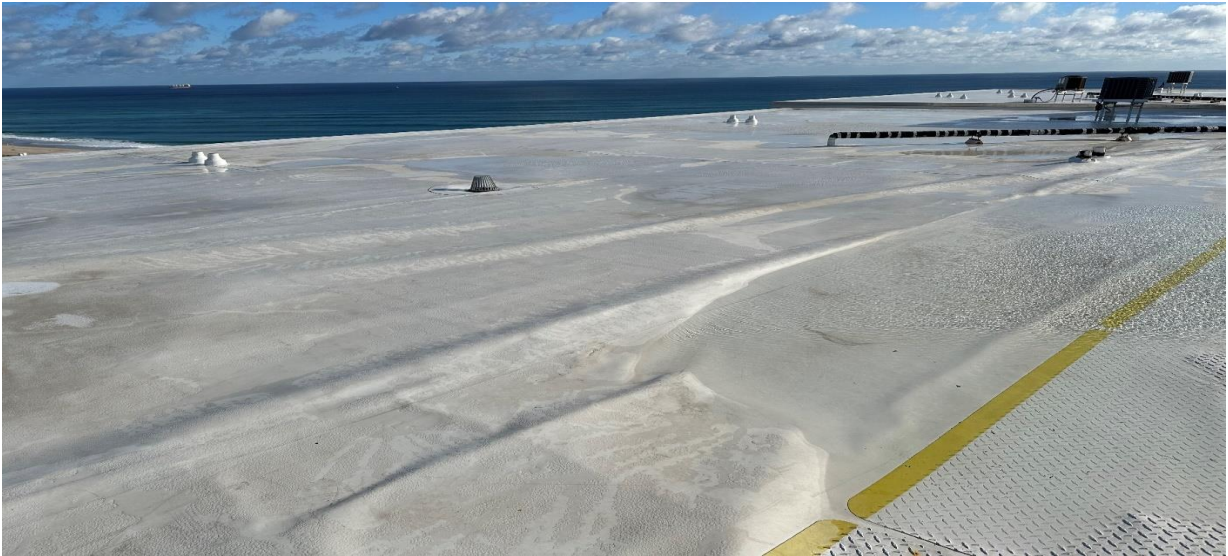
**Photo 4: West Tower Roof, Looking Northeast.**

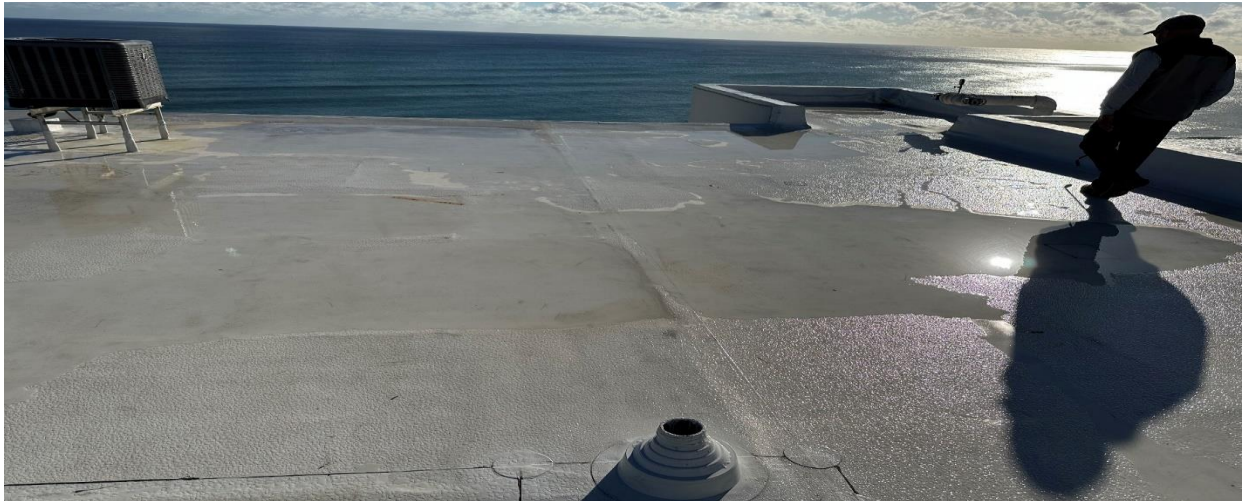
**Photo 6: East Tower Roof, Looking East**

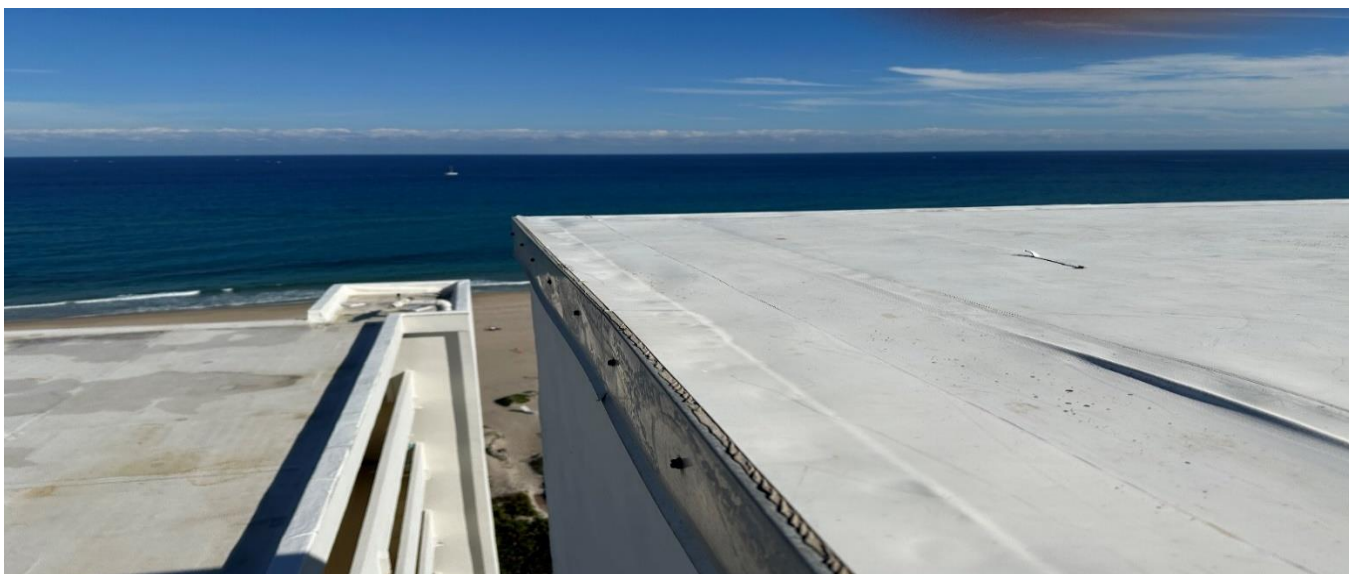
**Photo 7: Elevator Tower Roof, Looking East.**

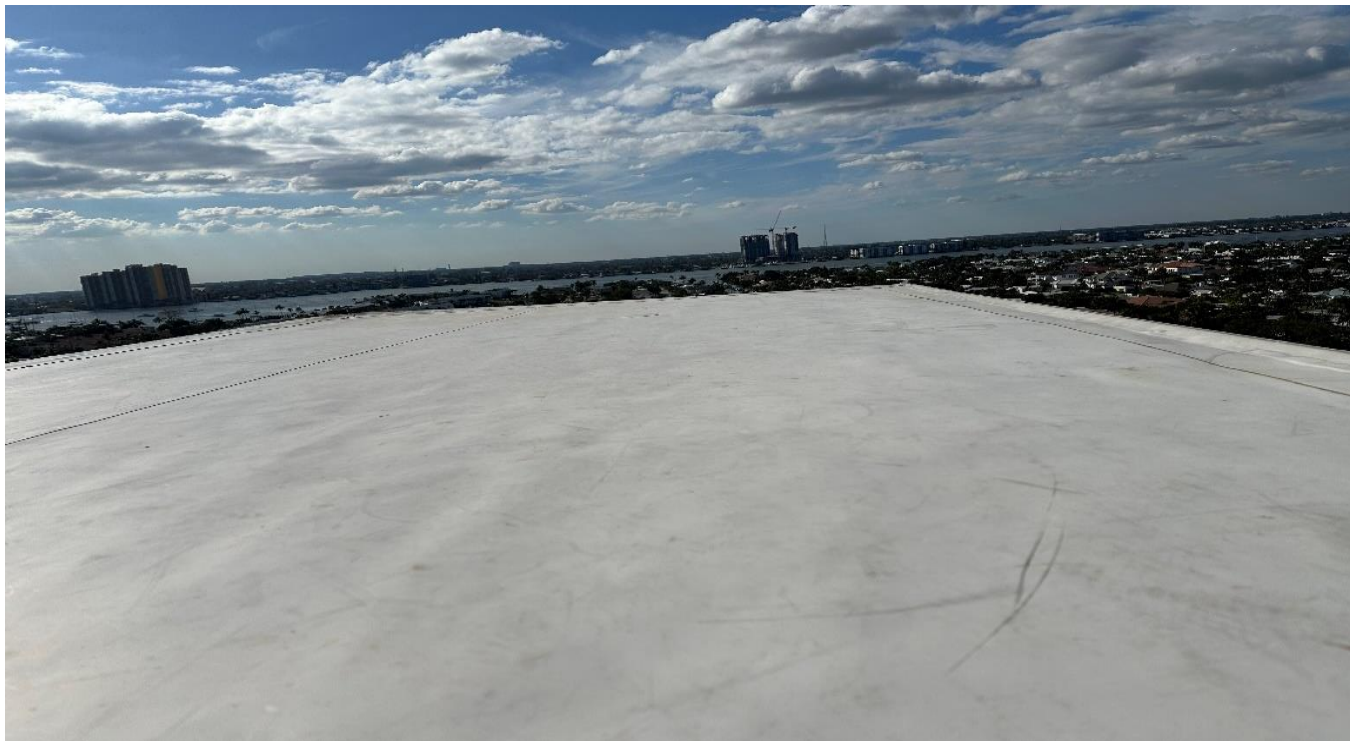
**Photo 9: East Tower Roof, Looking East**

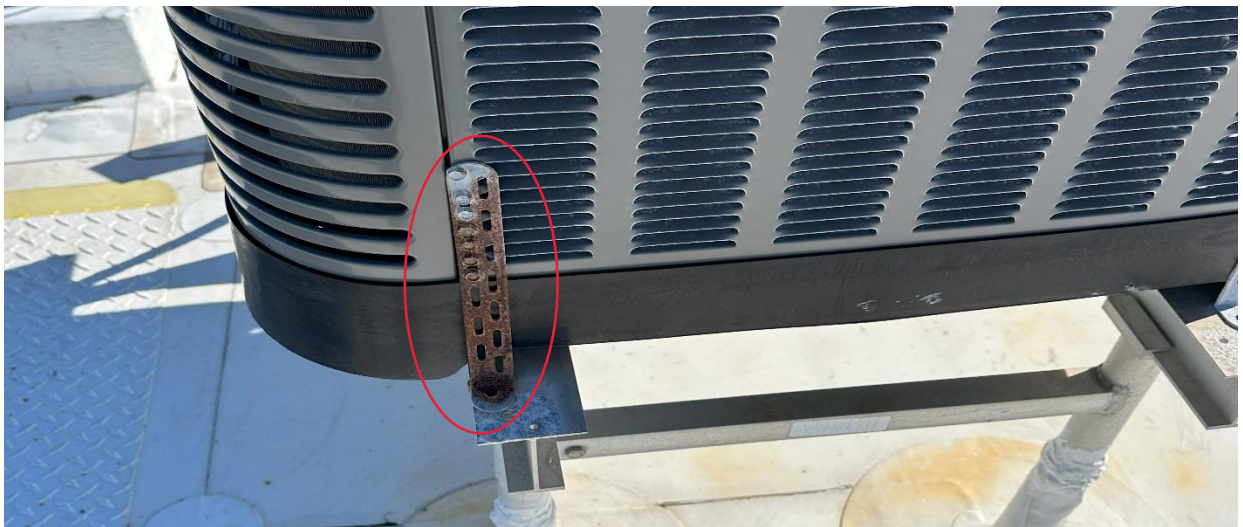
**Photo 10: AC Strap Corrosion Damage.**

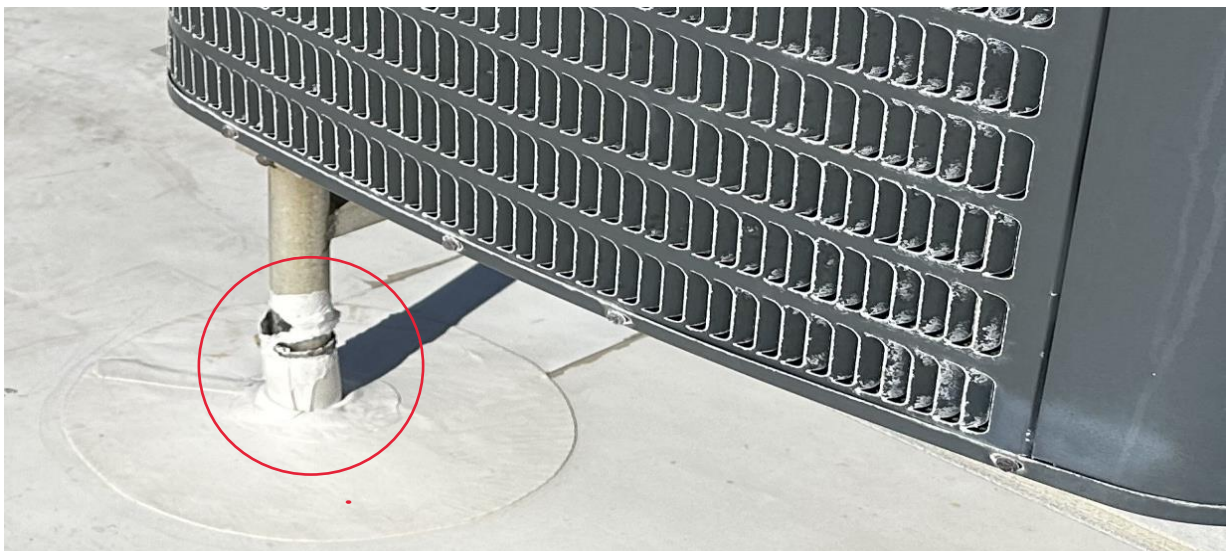
**Photo 11: AC Unit Boot Damage.**

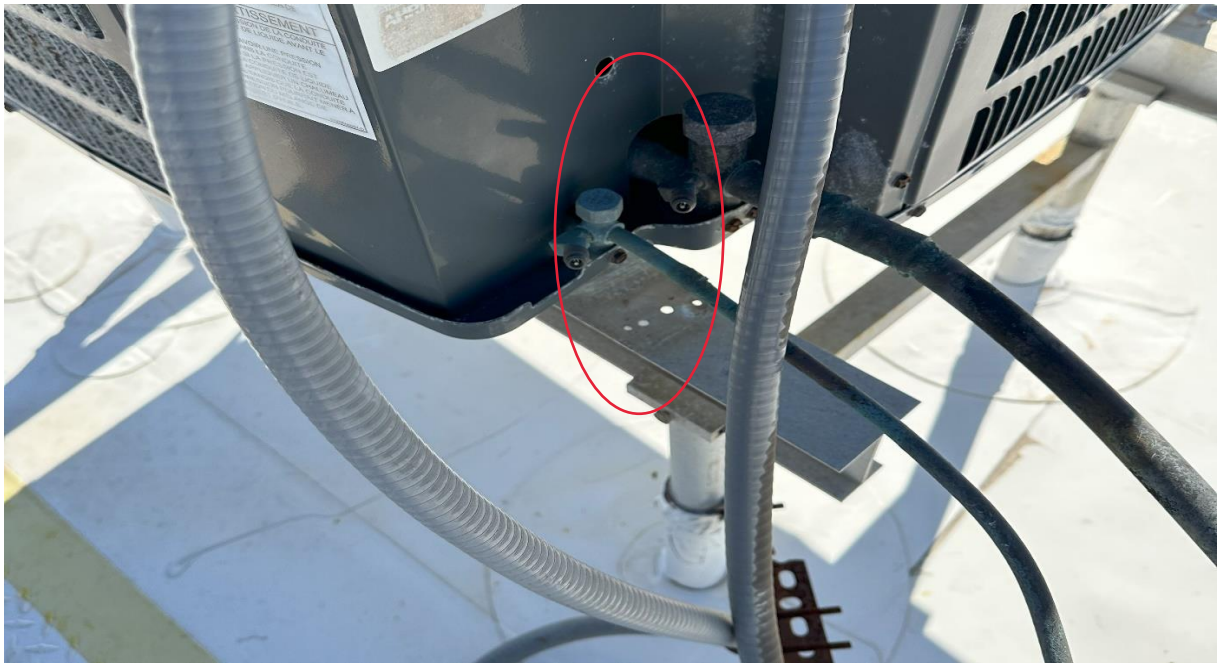
**Photo 12: AC Unit with a Missing Strap.**

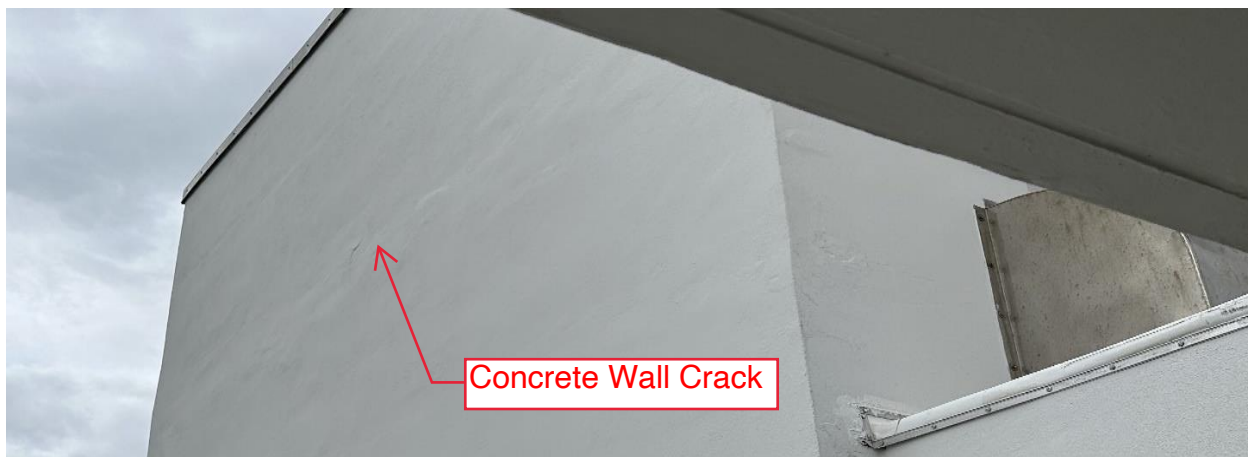
**Photo 13: Elevator Tower, East Elevation.**

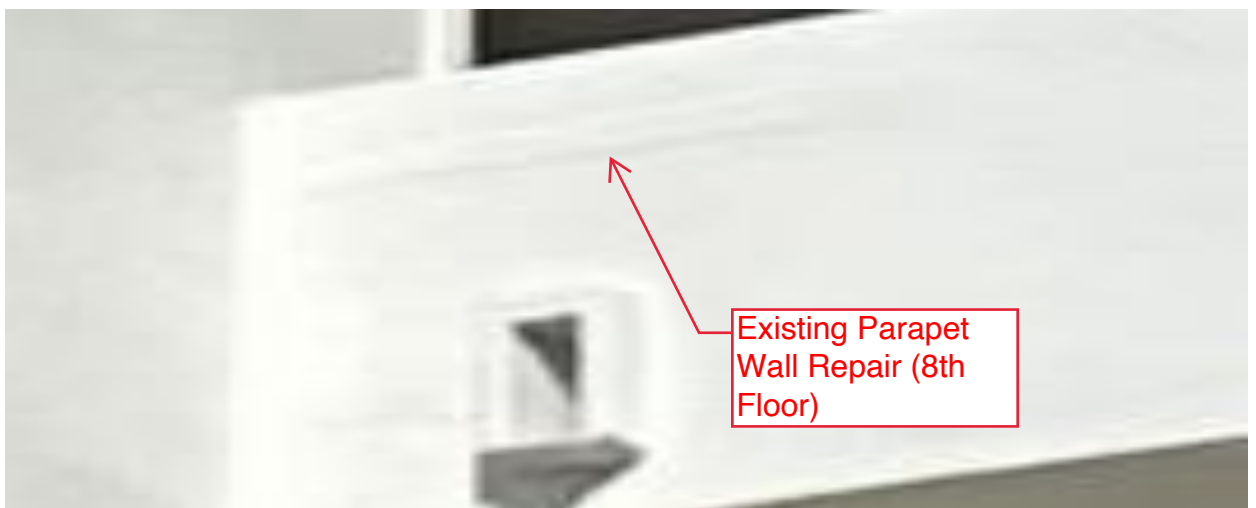
**Photo 16: South Elevation Walkways, Existing Parapet Wall Repair Prior to Building Painting.**

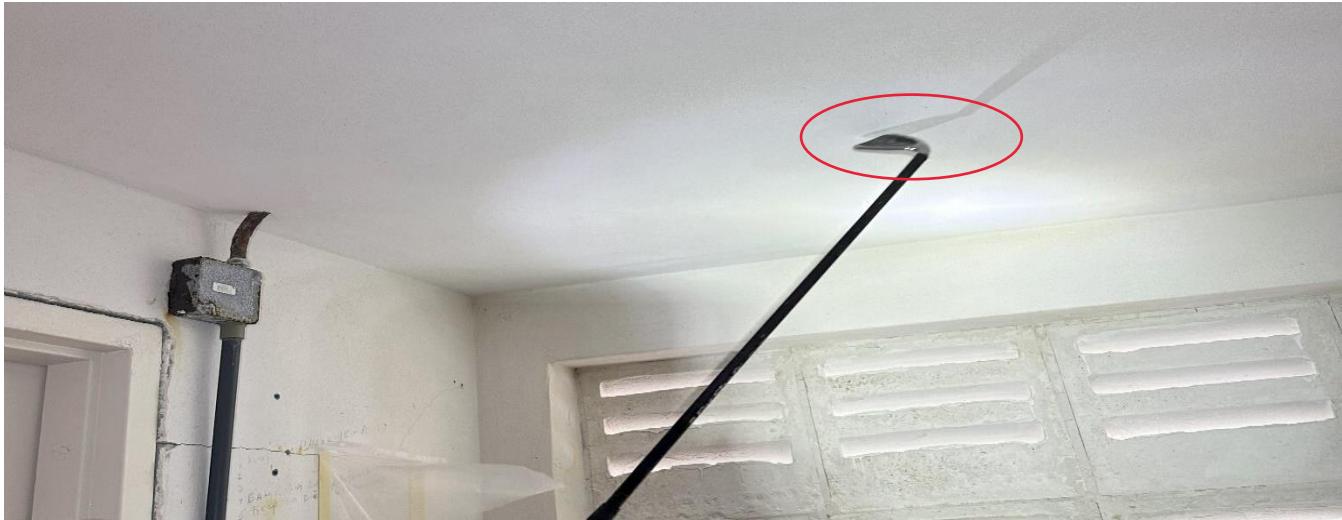
**Photo 17: Pool Pump Room Ceiling, Concrete Spall.**

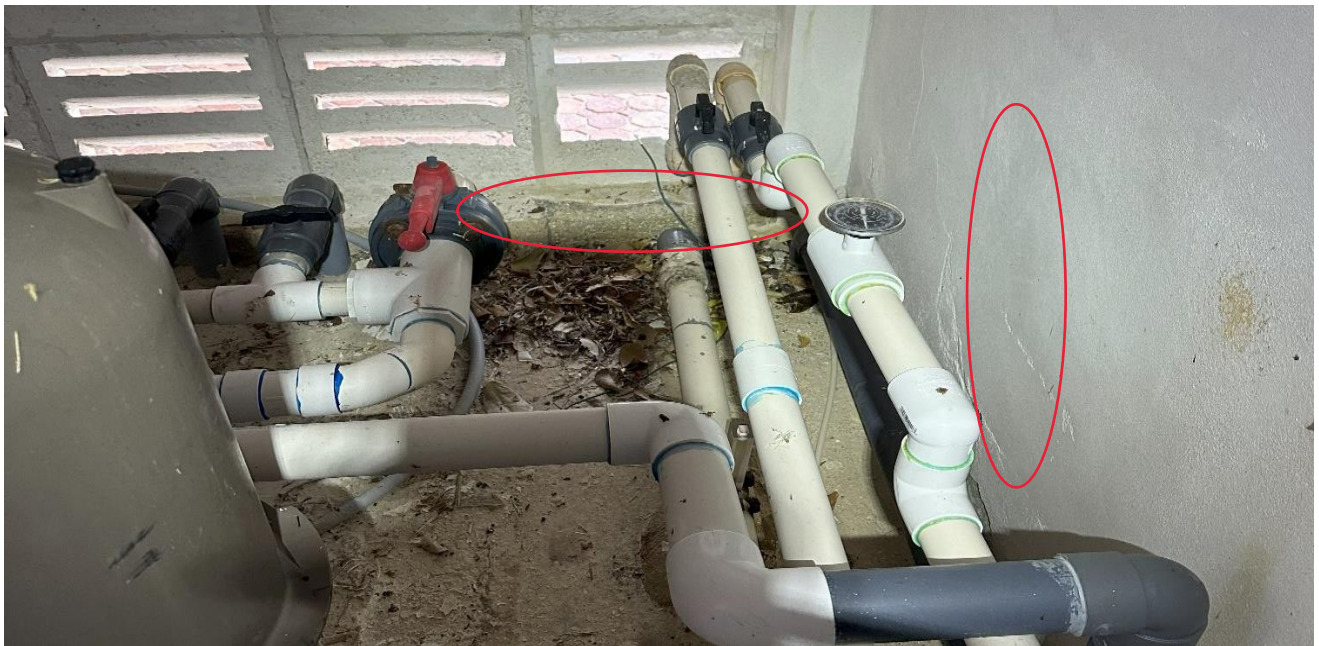
**Photo 18: Pool Pump Room Floor, Wall Spalls.**

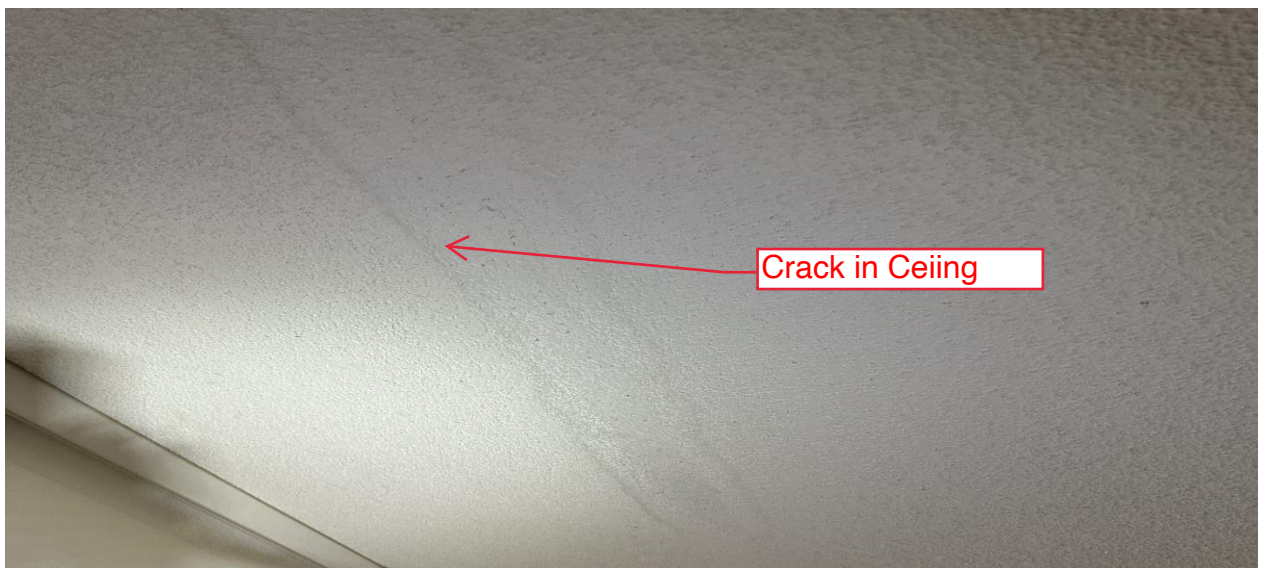
**Photo 19: Interior Ceiling, Concrete Crack.**

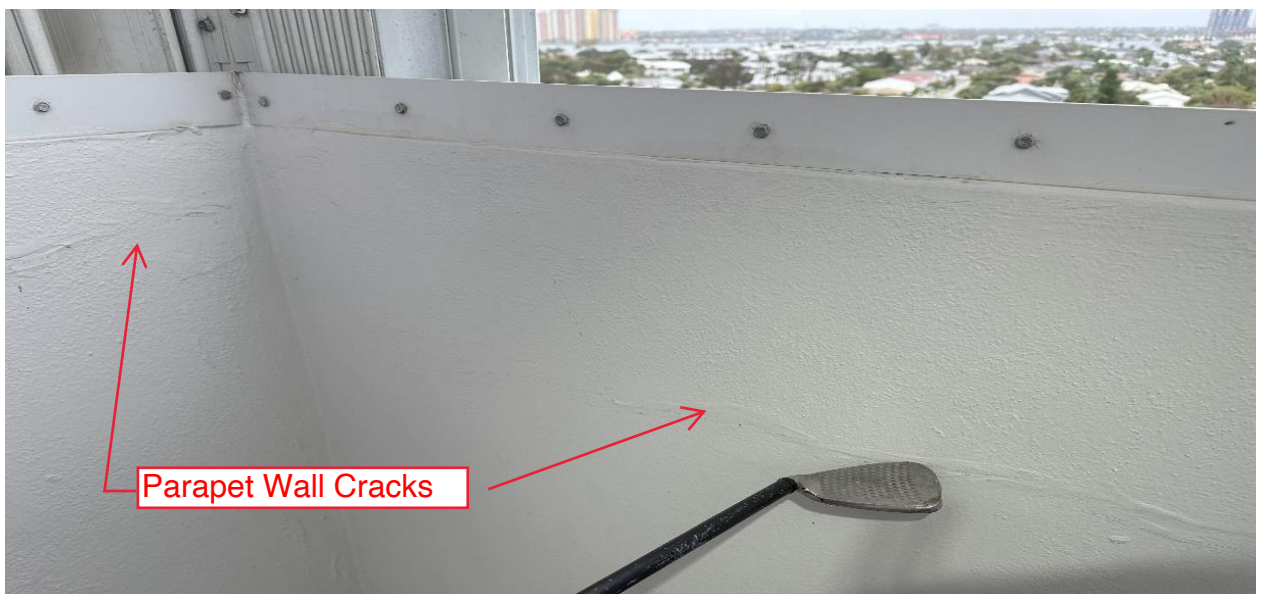
**Photo 20: Balcony Parapet Wall, Masonry Wall Cracks.**

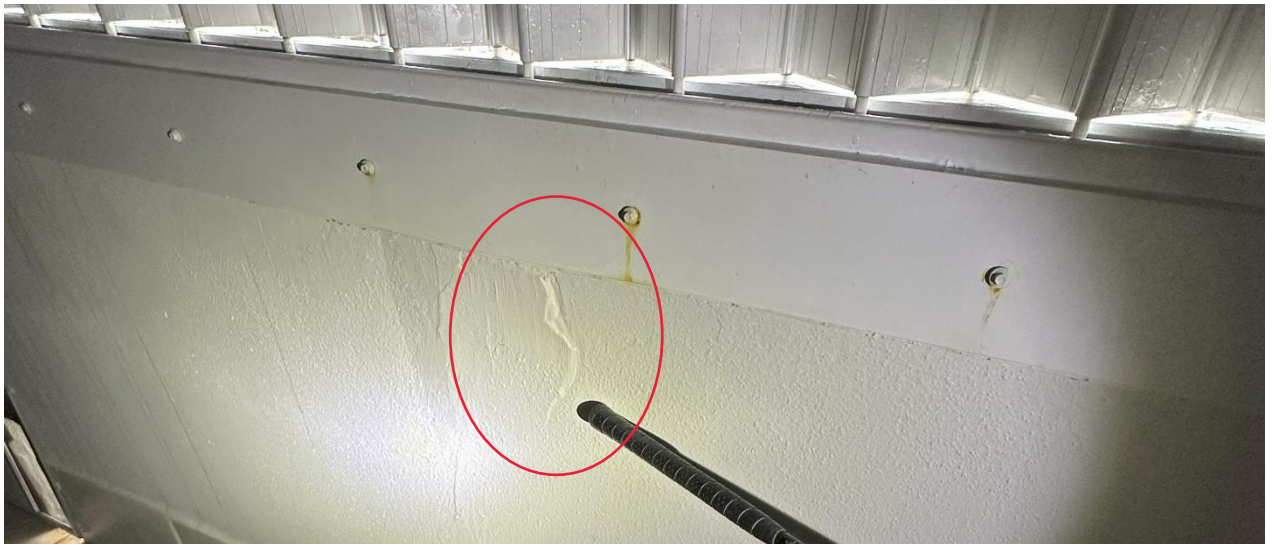
**Photo 21: Balcony Parapet Wall, Concrete Spall.**

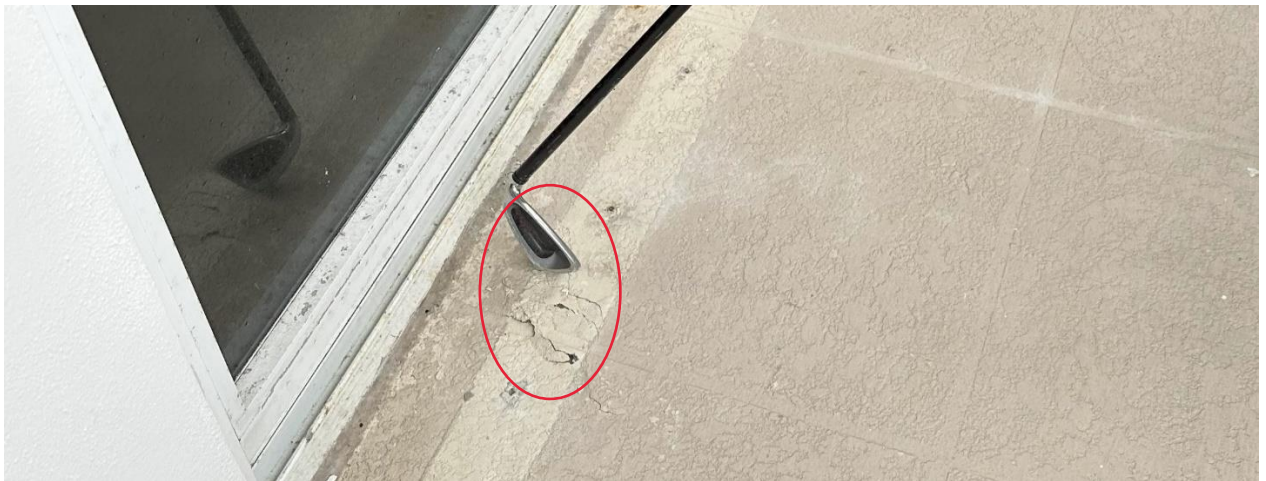
**Photo 22: Balcony Floor, Concrete Spall Caused by Unremoved Fasteners.**

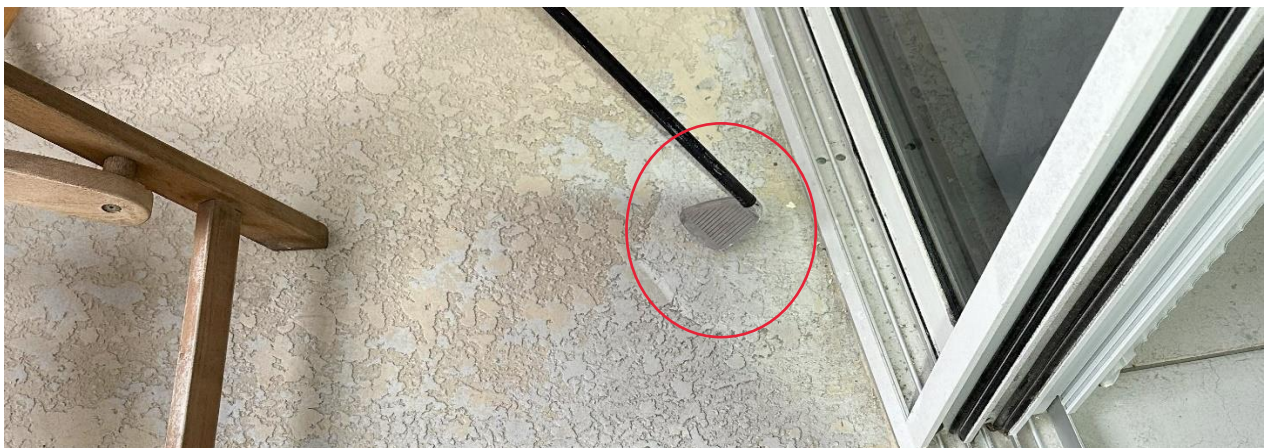
**Photo 23: Balcony Floor, Concrete Spall.**

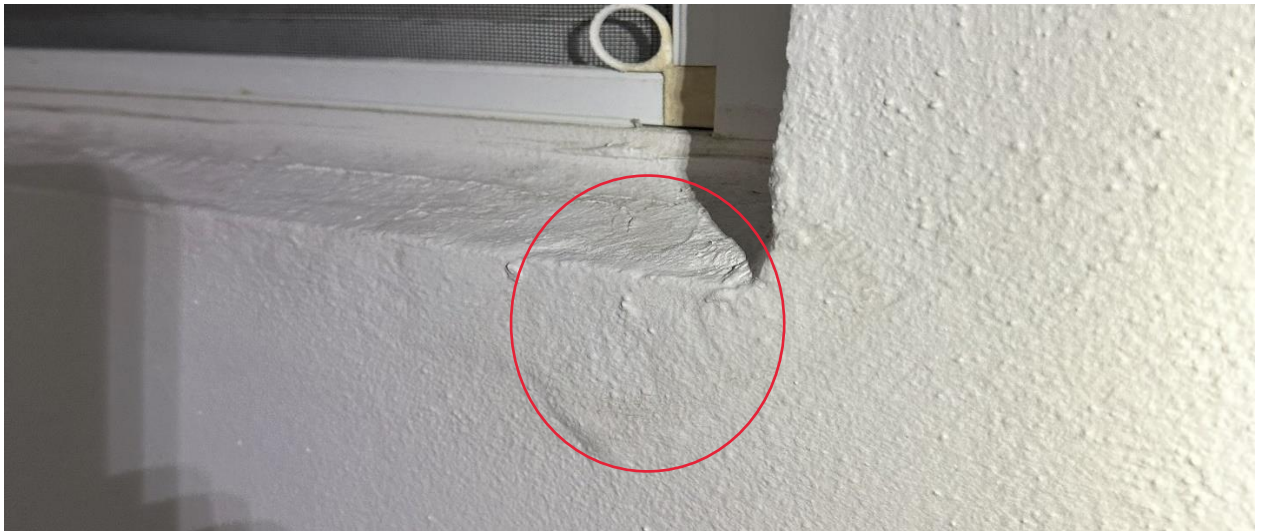
**Photo 24: Balcony Window Sill, Concrete Spall.**

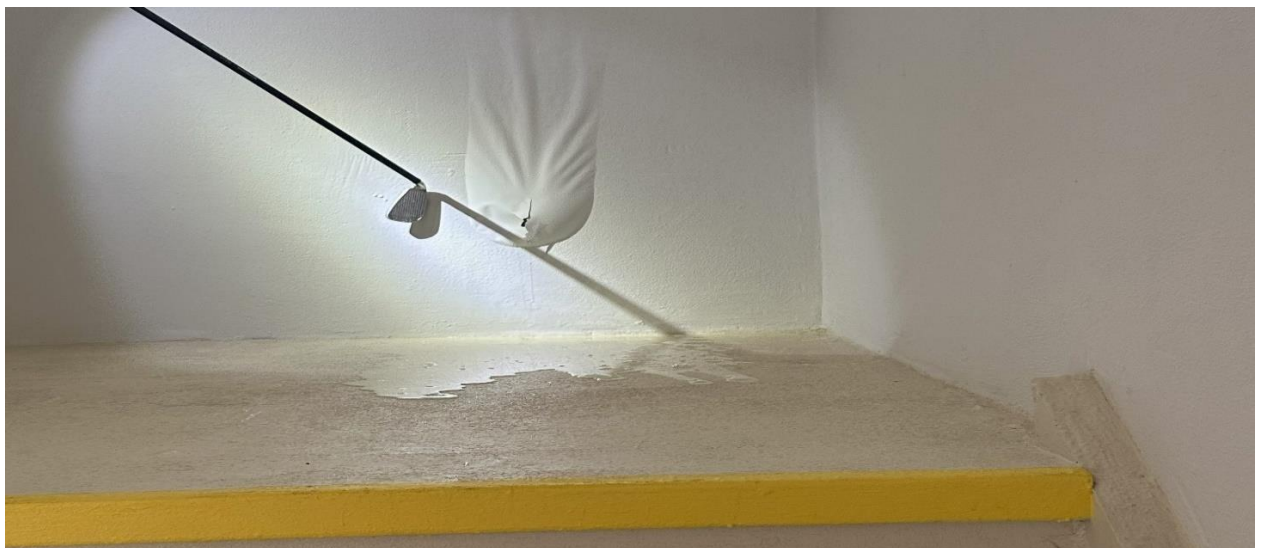
**Photo 25: East Stairway Tower, Water Intrusion.**

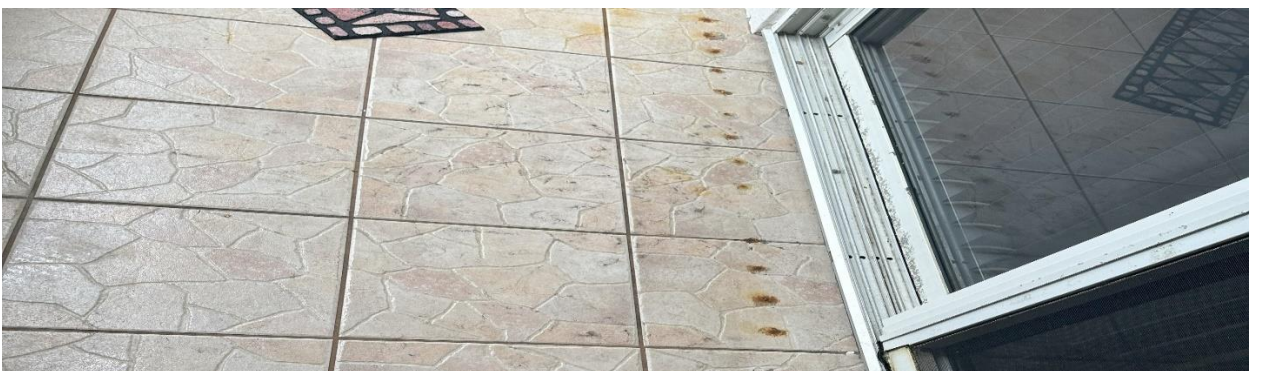
**Photo 26: Balcony Floor, Corroding Unremoved Fasteners.**

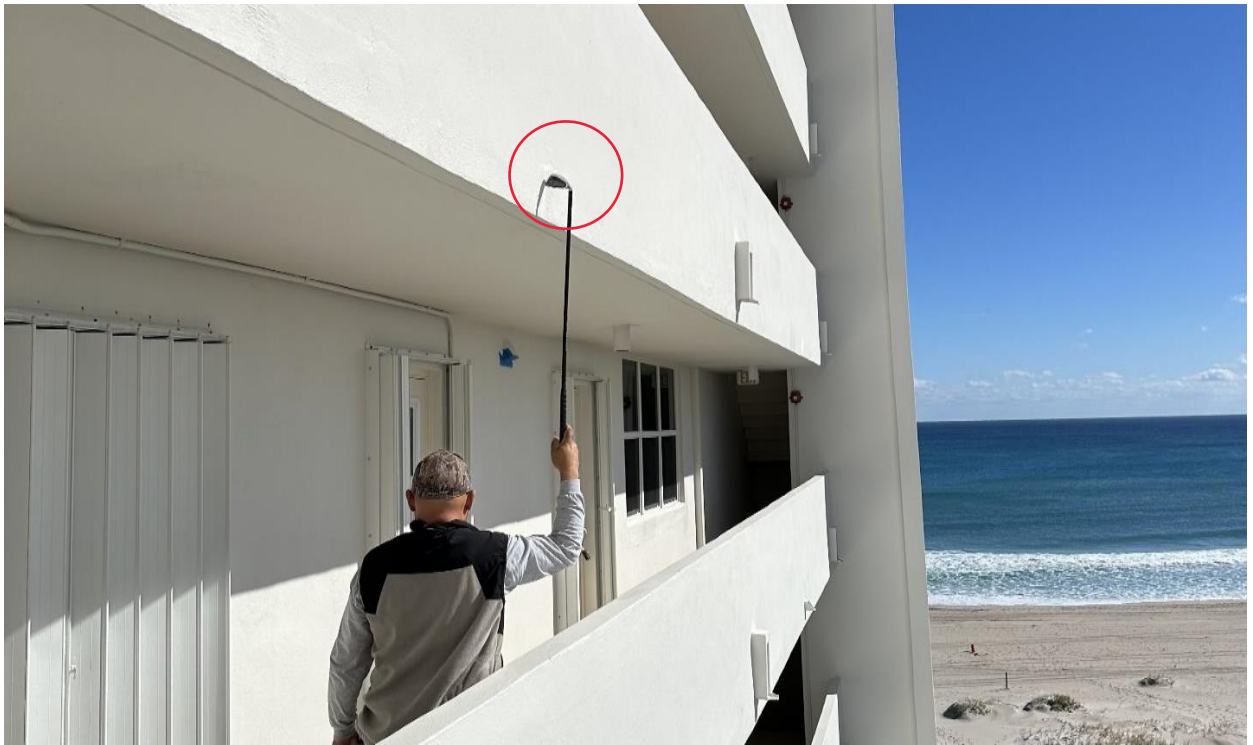
**Photo 27: South Elevation Walkways, Parapet Wall Spalls.**

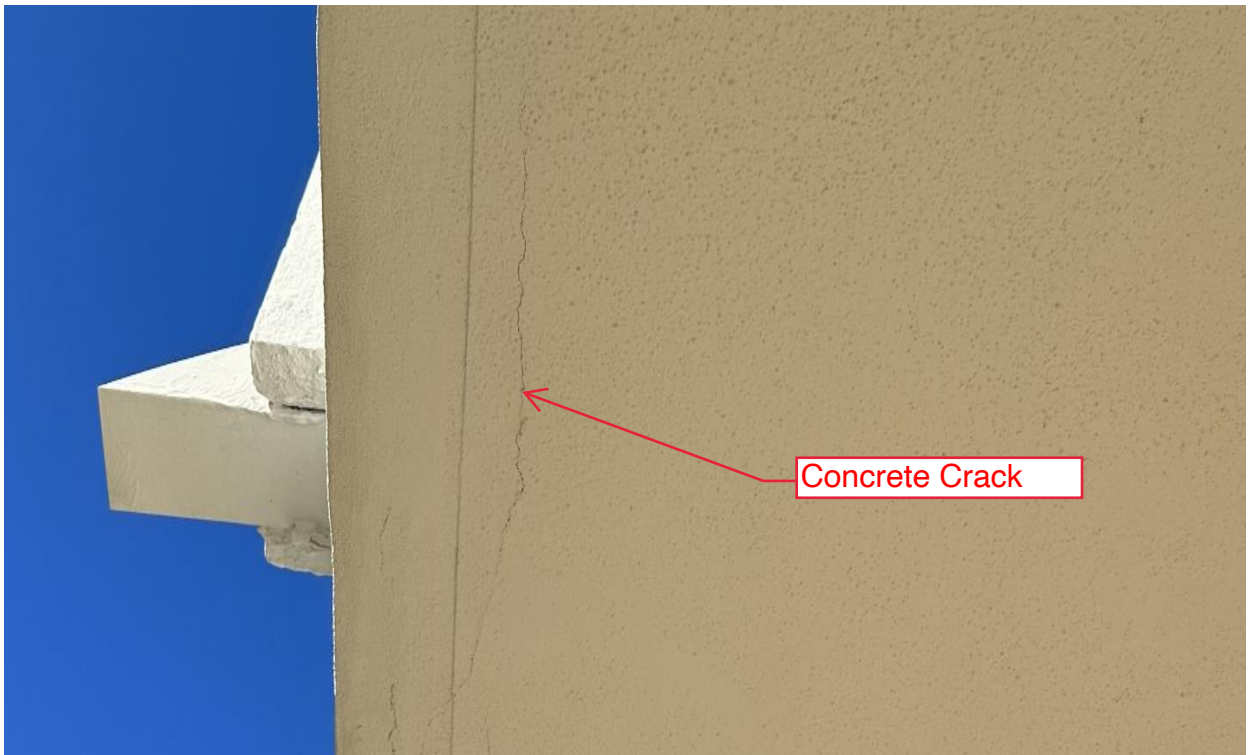
**Photo 28: South Elevation Walkways, Ceiling Concrete Crack.**

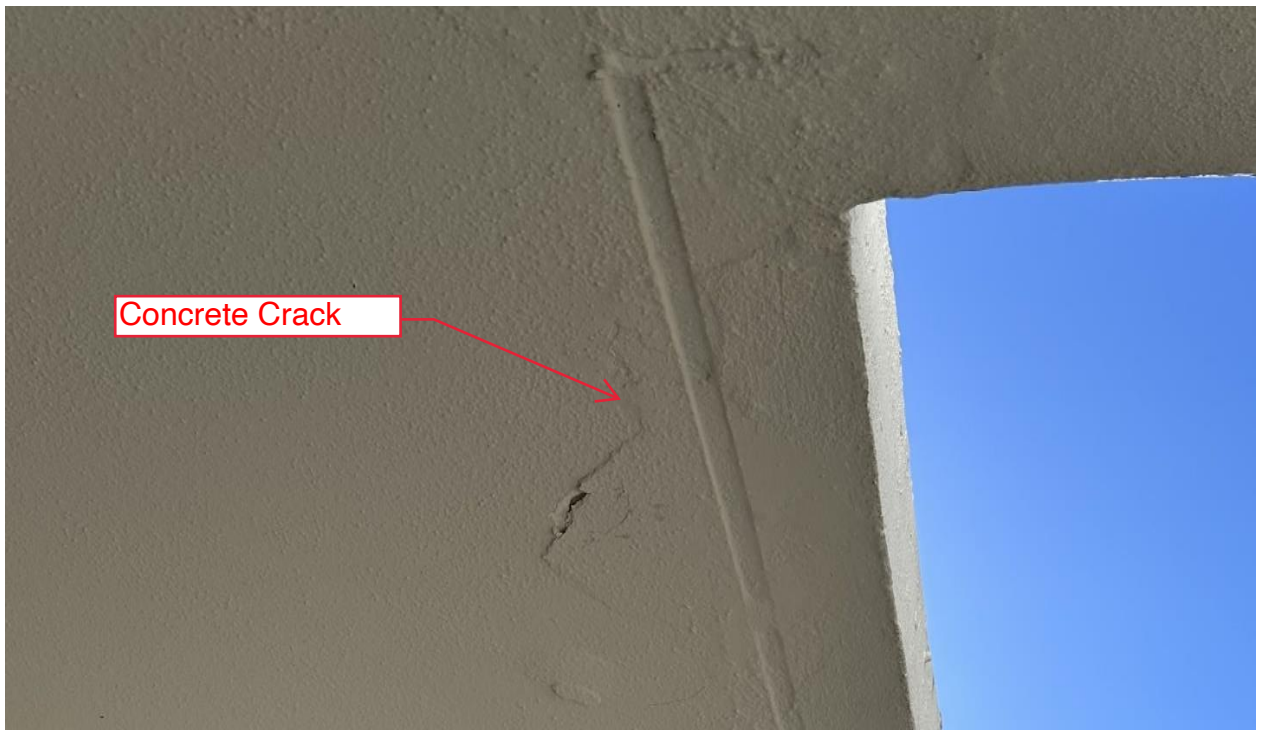
**Photo 29: South Elevation Walkways, Ceiling Concrete Crack.**

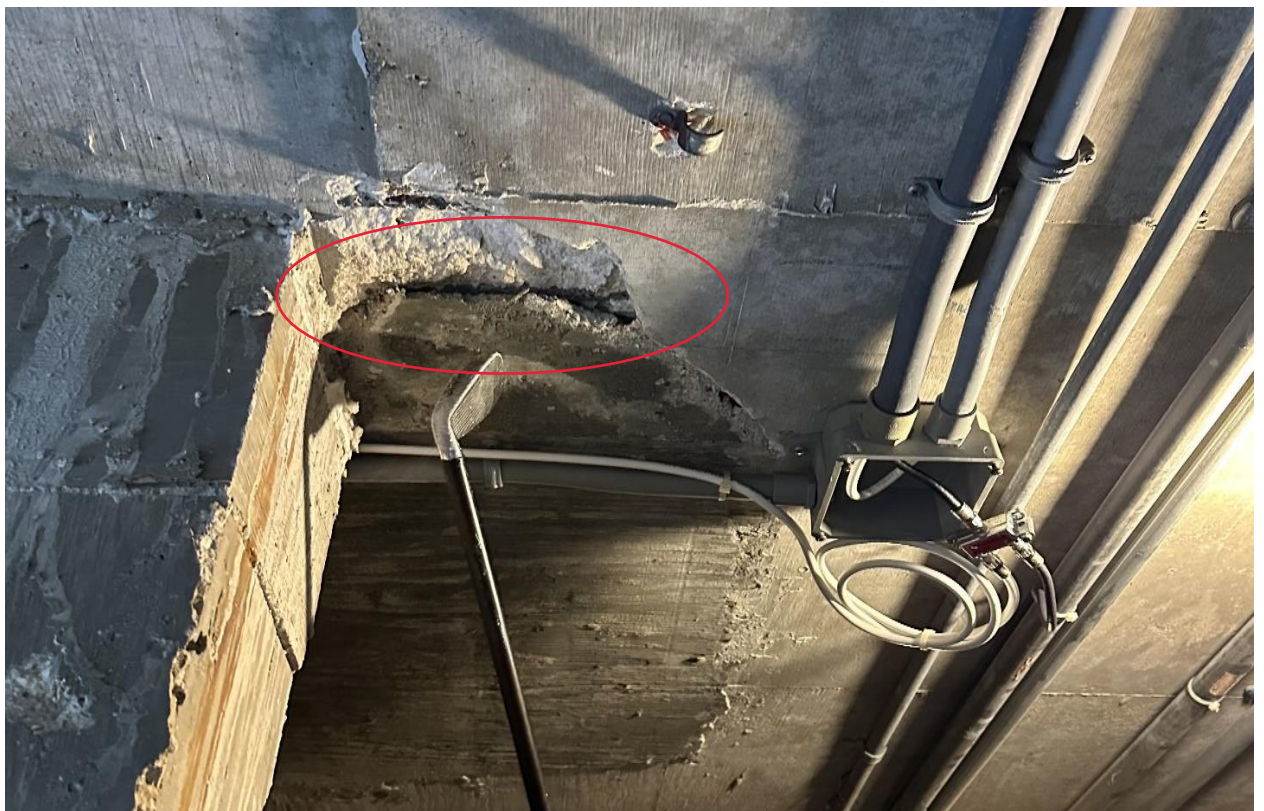
**Photo 30: Pump Room, Ceiling Spall with Exposed Rebar.**

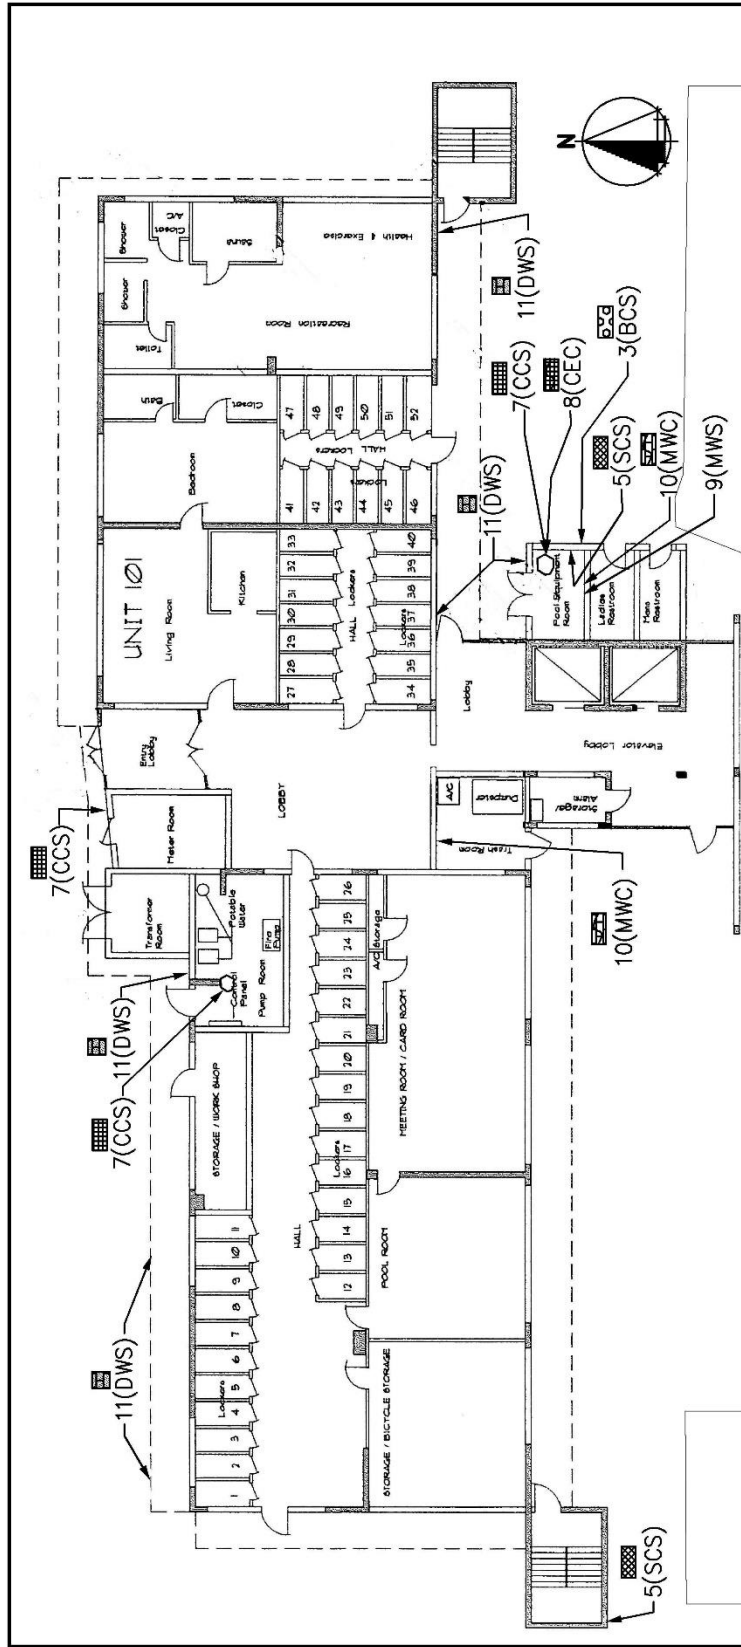
**NOTES:**  
FOR REPAIR DESCRIPTIONS SEE LEGEND BELOW.  
THE STRUCTURAL DAMAGE FOR THIS FLOOR IS MINOR COLUMN, CEILING & TIE BEAM CRACKS & SPALLS, MASONRY WALL CRACKS & SPALLS, AND DELAMINATED WALL & CEILING STUCCO.

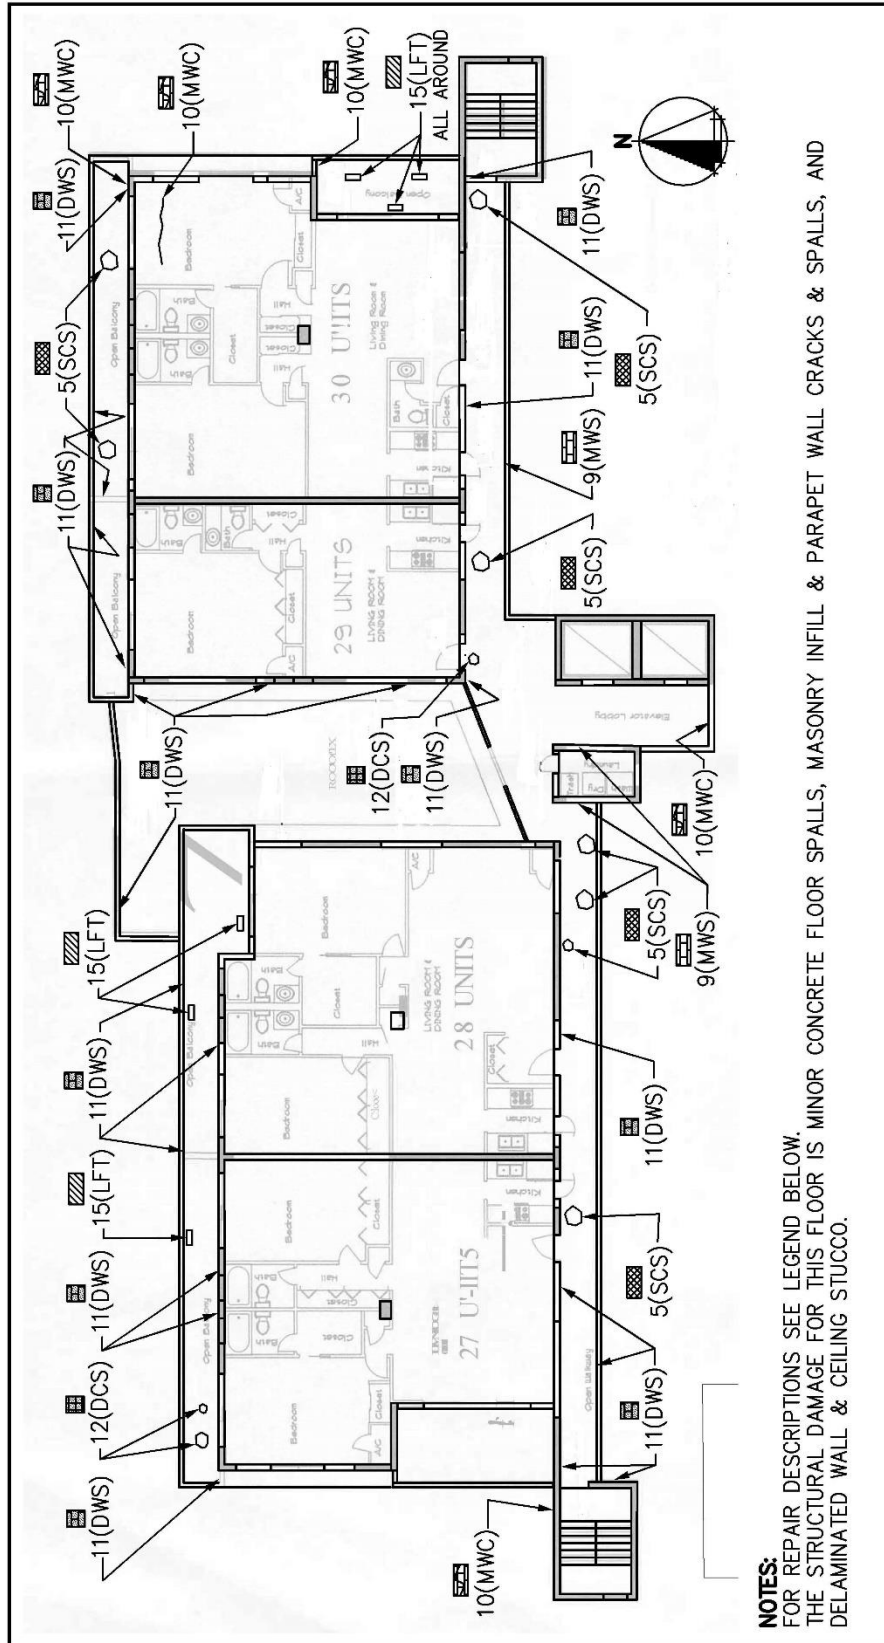
ARAL CONSULTING ENGINEERS, INC. COA # 4645	<b>1ST FLOOR PLAN - OBSERVED VISUAL DAMAGE</b>	
	<b>VILLA TOWERS CONDOMINIUM - MILESTONE INSPECTIONS</b> 3640 NORTH OCEAN DRIVE, SINGER ISLAND, FL 33040	DATE: 1/5/24 SCALE: N.T.S. REVISED: DRAWN BY: E.A.
721 US HWY. ONE SUITE 224 NORTH PALM BEACH FLORIDA 33408 (561) 840-7422	JOB no.: 2469801	SK-1
PROJECT NUMBER: 2469801

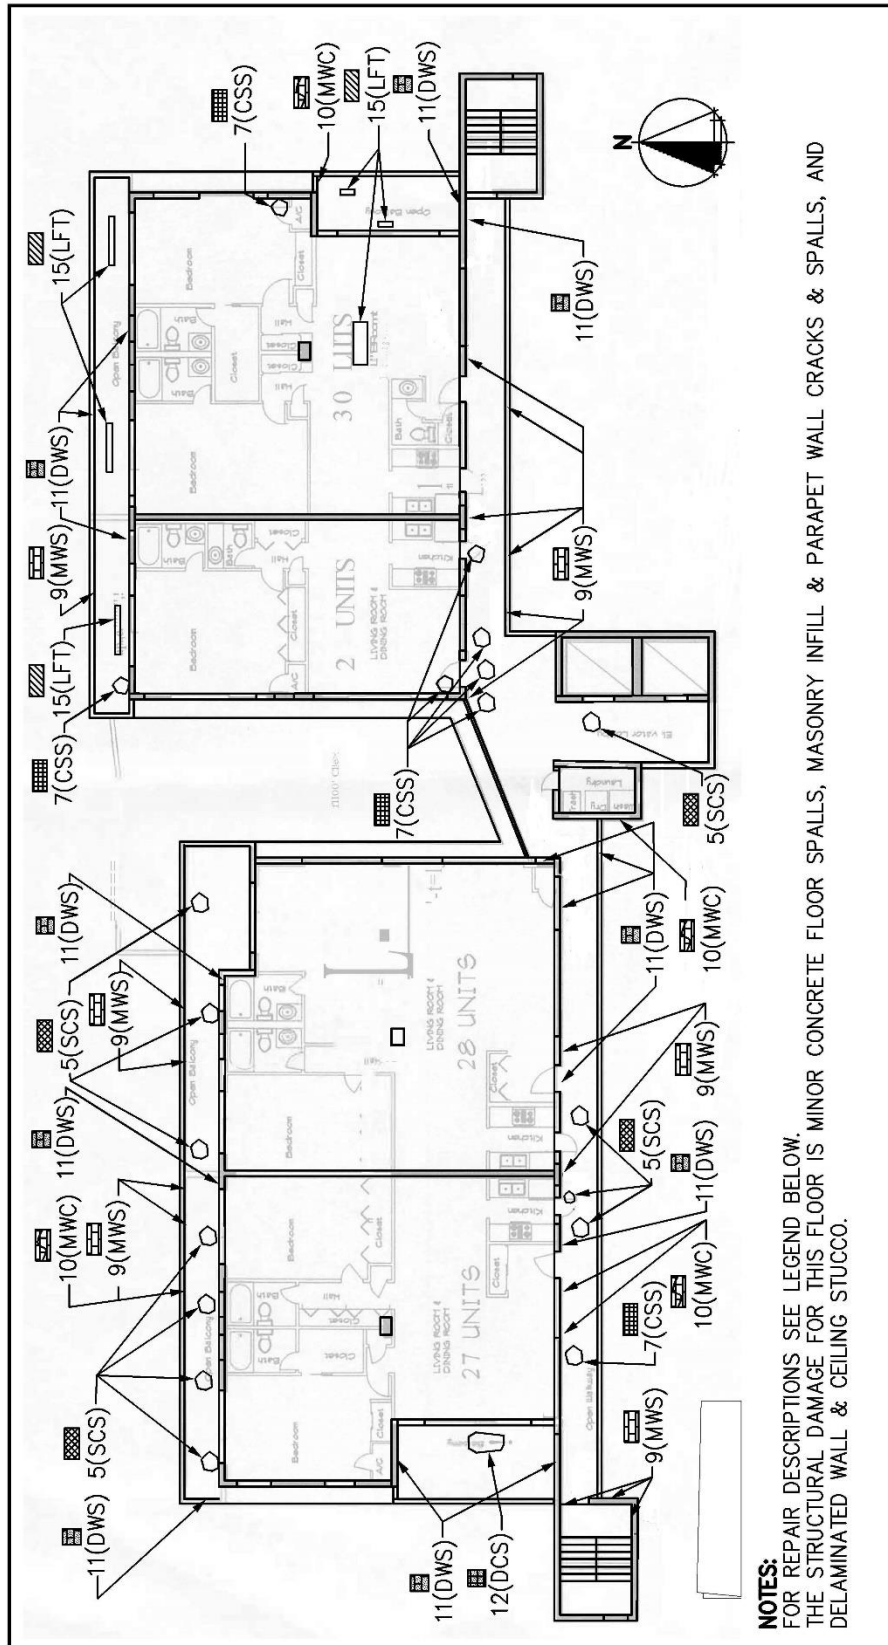
**NOTES:**  
FOR REPAIR DESCRIPTIONS SEE LEGEND BELOW.  
THE STRUCTURAL DAMAGE FOR THIS FLOOR IS MINOR CONCRETE FLOOR SPALLS, MASONRY INFILL & PARAPET WALL CRACKS & SPALLS, AND DELAMINATED WALL & CEILING STUCCO.

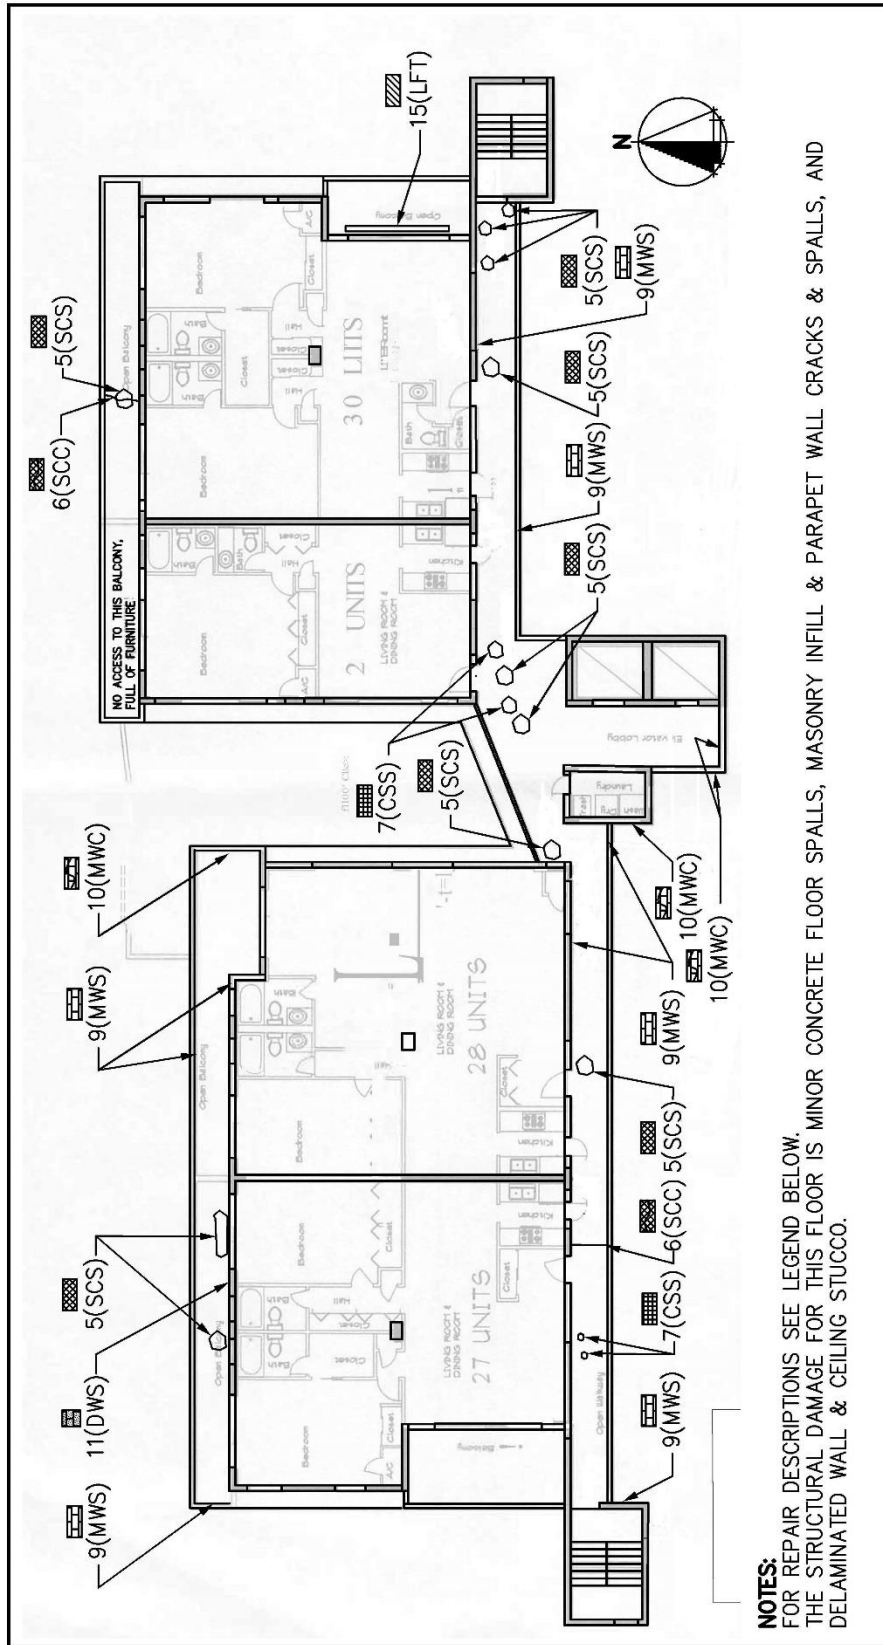
**NOTES:**  
FOR REPAIR DESCRIPTIONS SEE LEGEND BELOW.  
THE STRUCTURAL DAMAGE FOR THIS FLOOR IS MINOR CONCRETE FLOOR SPALLS, MASONRY INFILL & PARAPET WALL CRACKS & SPALLS, AND DELAMINATED WALL & CEILING STUCCO.
