**Date: January 31, 2024**

**To: City of Riviera Beach Building Department**  
600 West Blue Heron Blvd, @214C  
Riviera Beach, FL 33404

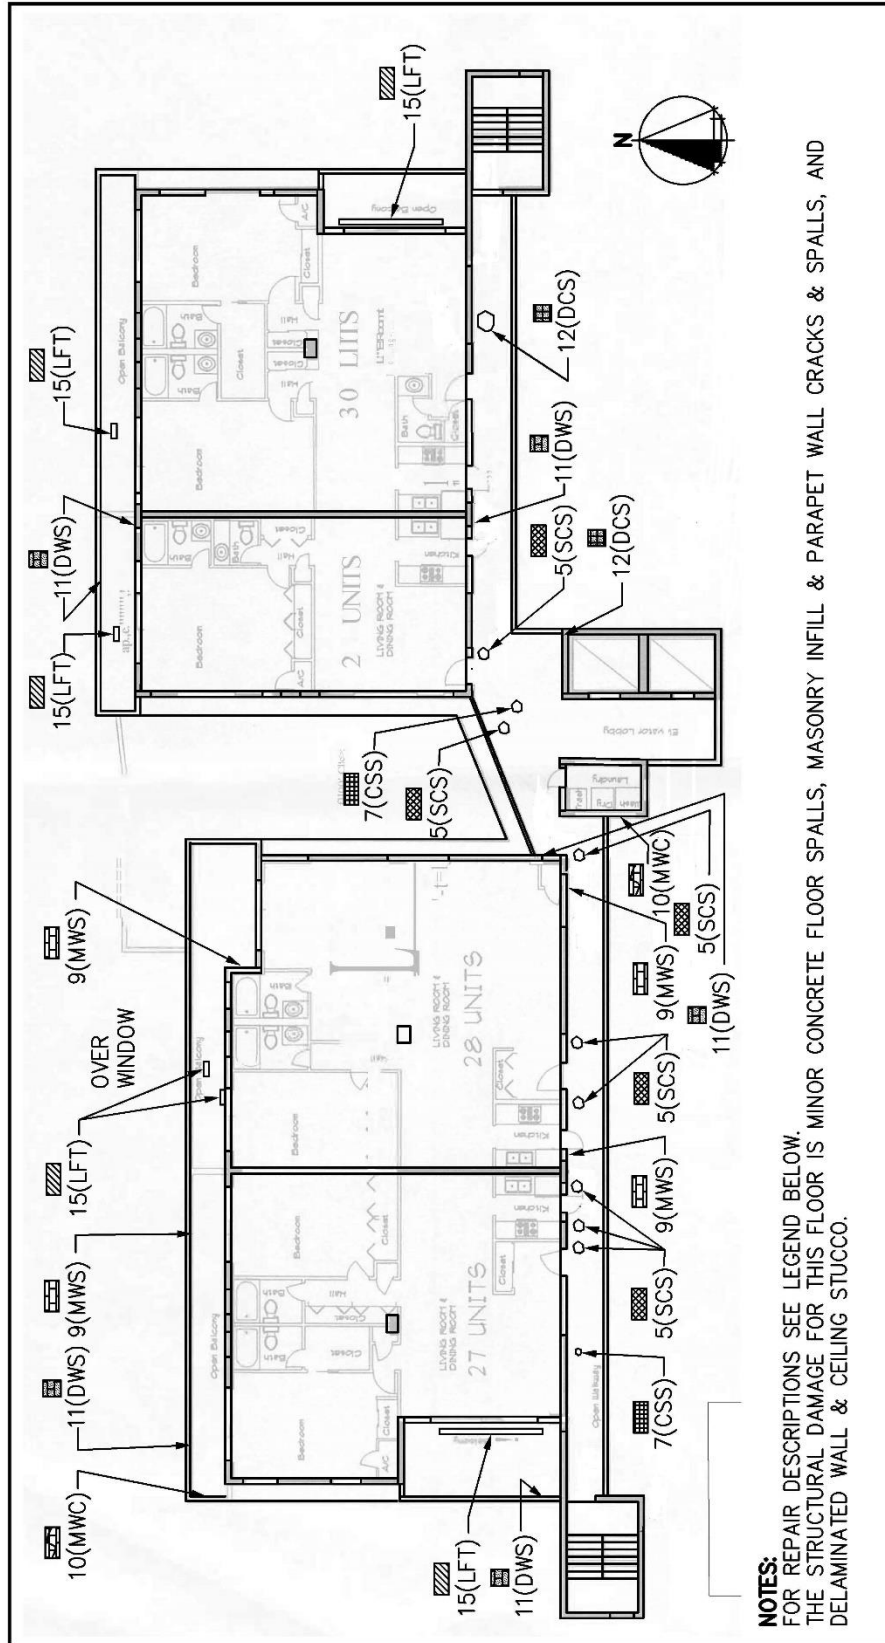
**NOTES:**  
FOR REPAIR DESCRIPTIONS SEE LEGEND BELOW.  
THE STRUCTURAL DAMAGE FOR THIS FLOOR IS MINOR CONCRETE FLOOR SPALLS, MASONRY INFILL & PARAPET WALL CRACKS & SPALLS, AND DELAMINATED WALL & CEILING STUCCO.

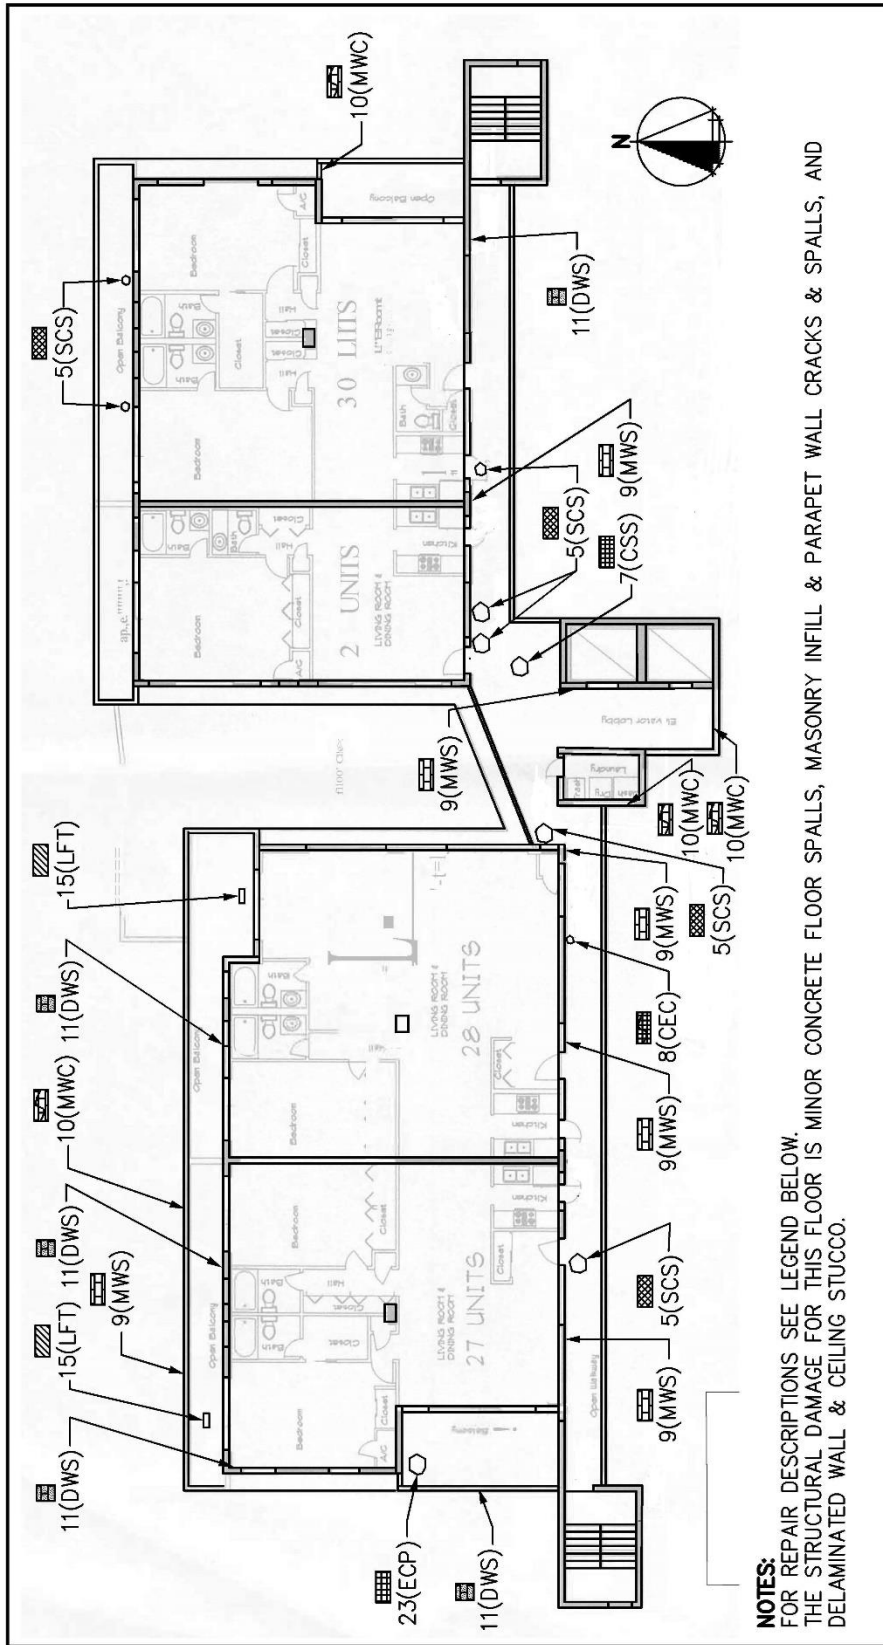
**NOTES:**  
FOR REPAIR DESCRIPTIONS SEE LEGEND BELOW.  
THE STRUCTURAL DAMAGE FOR THIS FLOOR IS MINOR CONCRETE FLOOR SPALLS, MASONRY INFILL & PARAPET WALL CRACKS & SPALLS, AND DELAMINATED WALL & CEILING STUCCO.

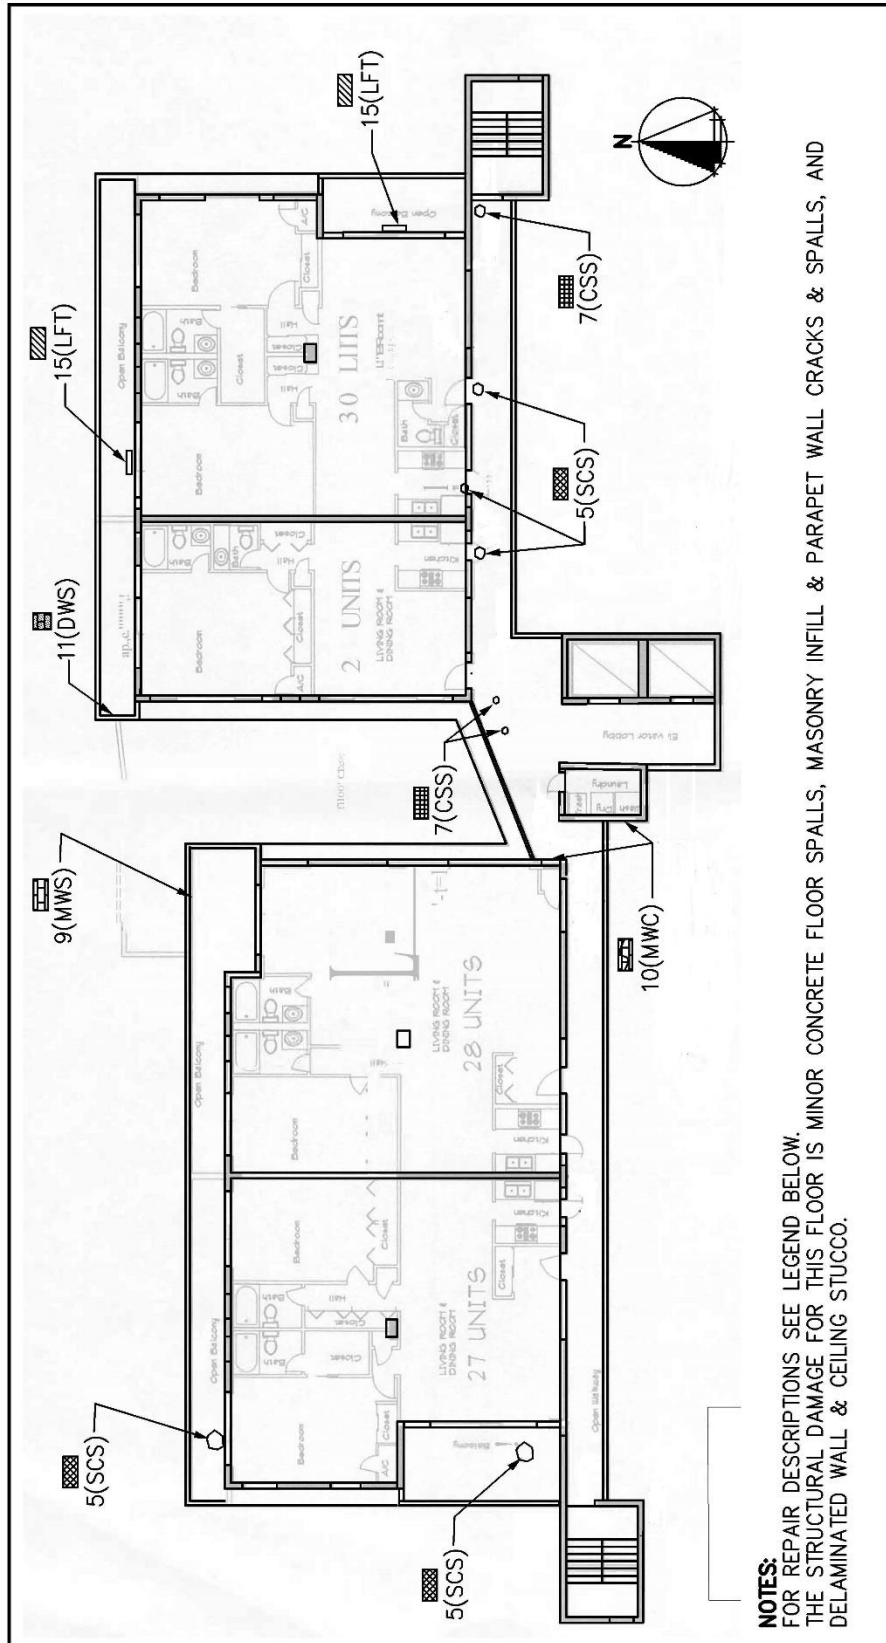
**NOTES:**  
FOR REPAIR DESCRIPTIONS SEE LEGEND BELOW.  
THE STRUCTURAL DAMAGE FOR THIS FLOOR IS MINOR CONCRETE FLOOR SPALLS, MASONRY INFILL & PARAPET WALL CRACKS & SPALLS, AND DELAMINATED WALL & CEILING STUCCO.

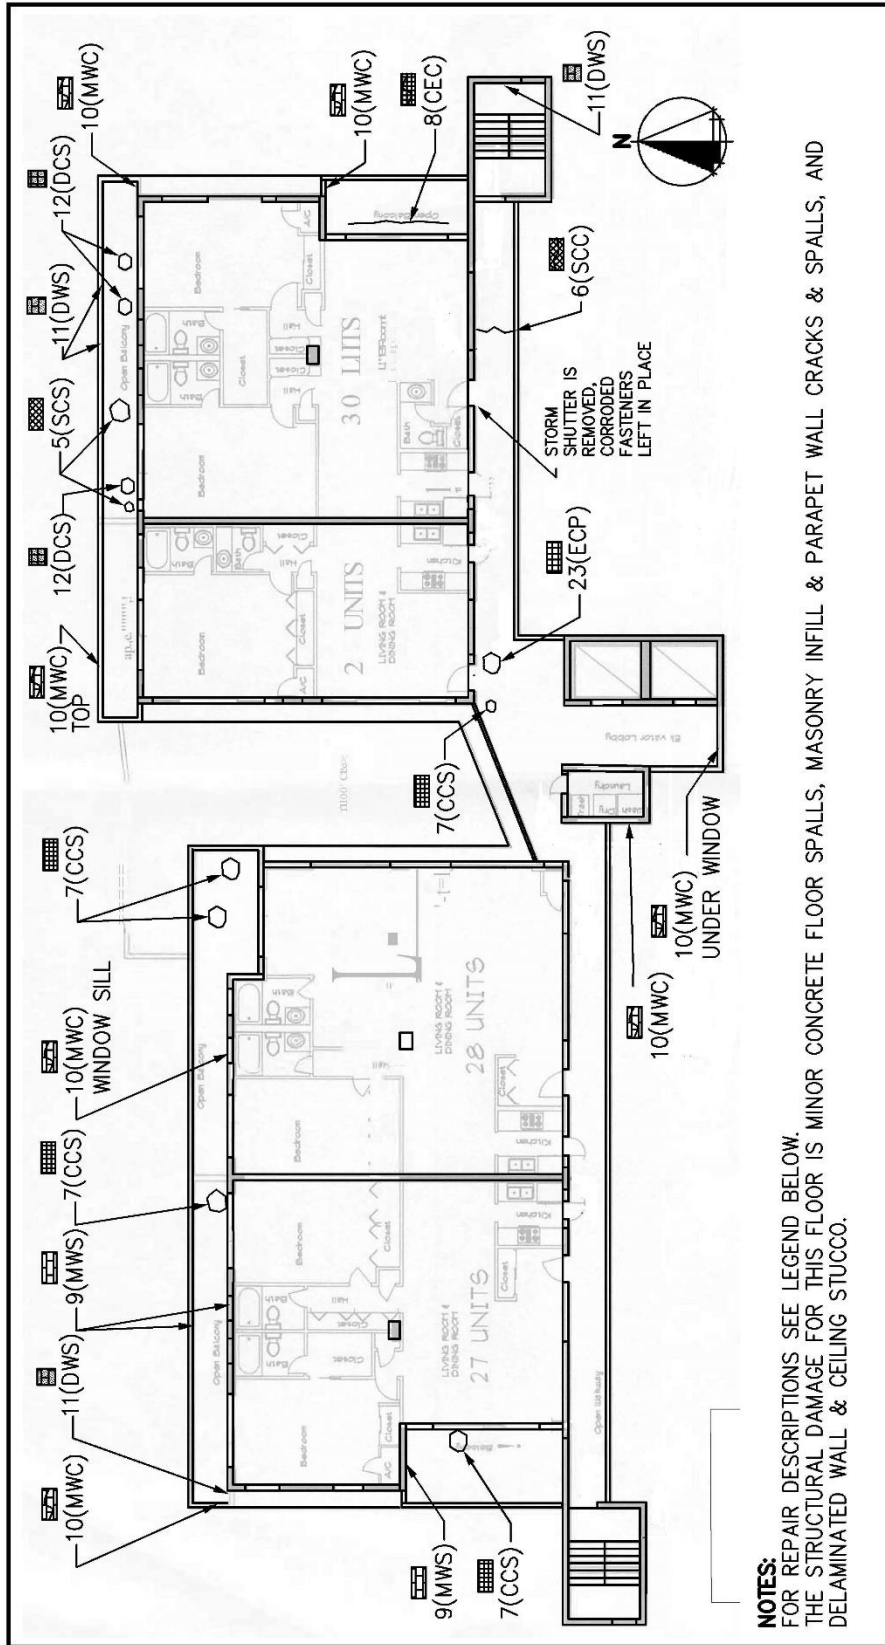
**NOTES:**  
FOR REPAIR DESCRIPTIONS SEE LEGEND BELOW.  
THE STRUCTURAL DAMAGE FOR THIS FLOOR IS MINOR CONCRETE FLOOR SPALLS, MASONRY INFILL & PARAPET WALL CRACKS & SPALLS, AND DELAMINATED WALL & CEILING STUCCO.

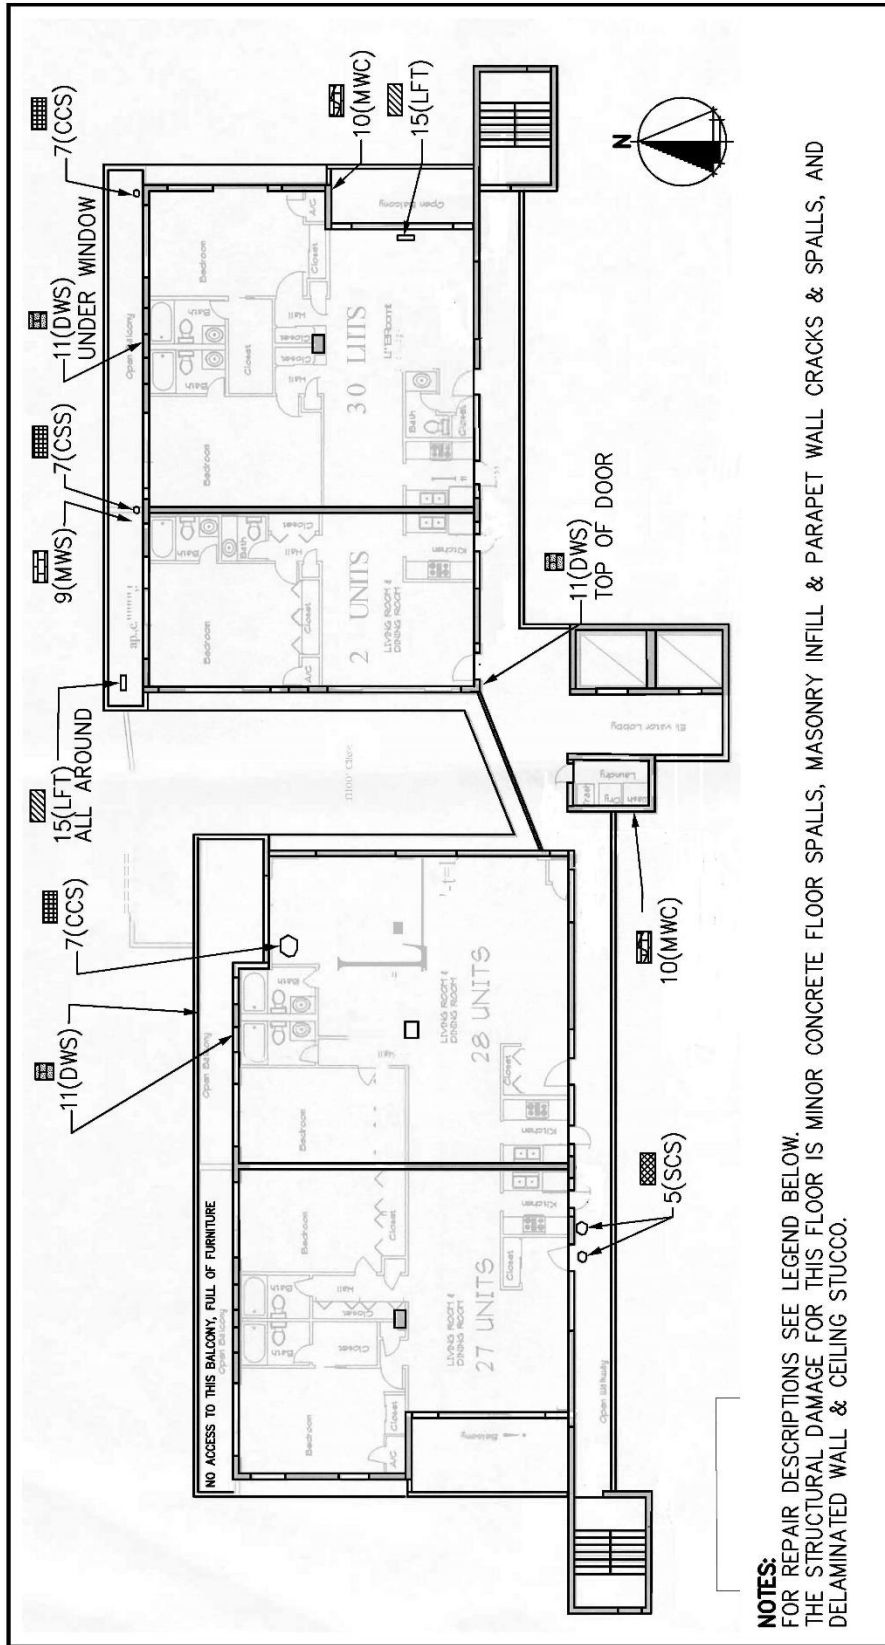
**NOTES:**  
FOR REPAIR DESCRIPTIONS SEE LEGEND BELOW.  
THE STRUCTURAL DAMAGE FOR THIS FLOOR IS MINOR CONCRETE FLOOR SPALLS, MASONRY INFILL & PARAPET WALL CRACKS & SPALLS, AND DELAMINATED WALL & CEILING STUCCO.

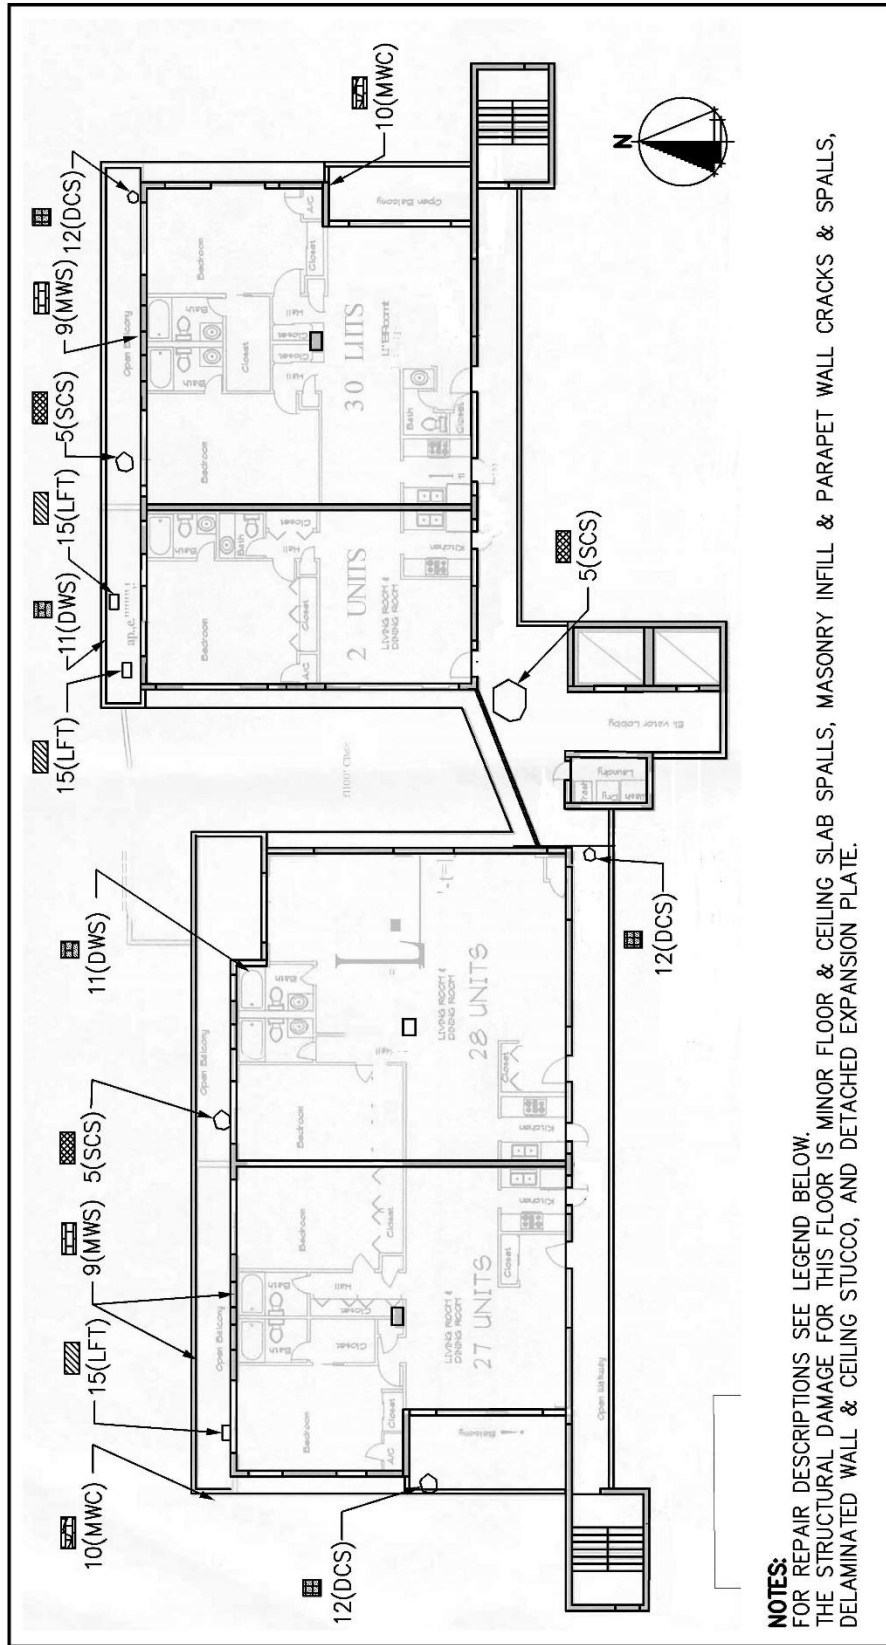
**NOTES:**  
FOR REPAIR DESCRIPTIONS SEE LEGEND BELOW.  
THE STRUCTURAL DAMAGE FOR THIS FLOOR IS MINOR FLOOR & CEILING SLAB SPALLS, MASONRY INFILL & PARAPET WALL CRACKS & SPALLS, DELAMINATED WALL & CEILING STUCCO, AND DETACHED EXPANSION PLATE.

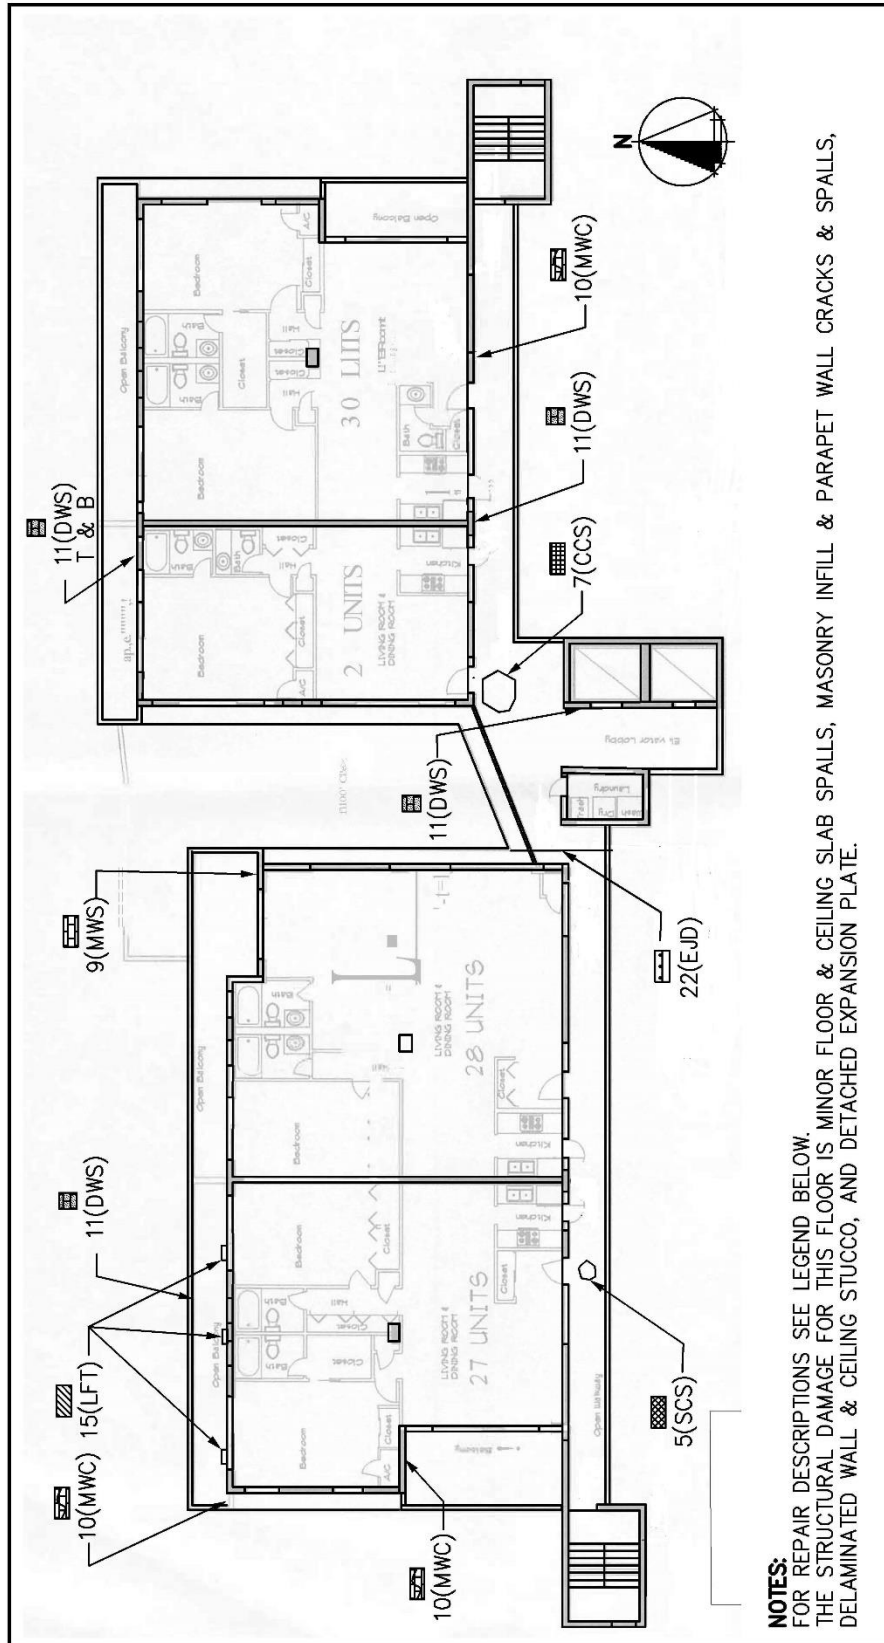
**NOTES:**  
FOR REPAIR DESCRIPTIONS SEE LEGEND BELOW.  
THE STRUCTURAL DAMAGE FOR THIS FLOOR IS MINOR FLOOR & CEILING SLAB SPALLS, MASONRY INFILL & PARAPET WALL CRACKS & SPALLS, DELAMINATED WALL & CEILING STUCCO, AND DETACHED EXPANSION PLATE.

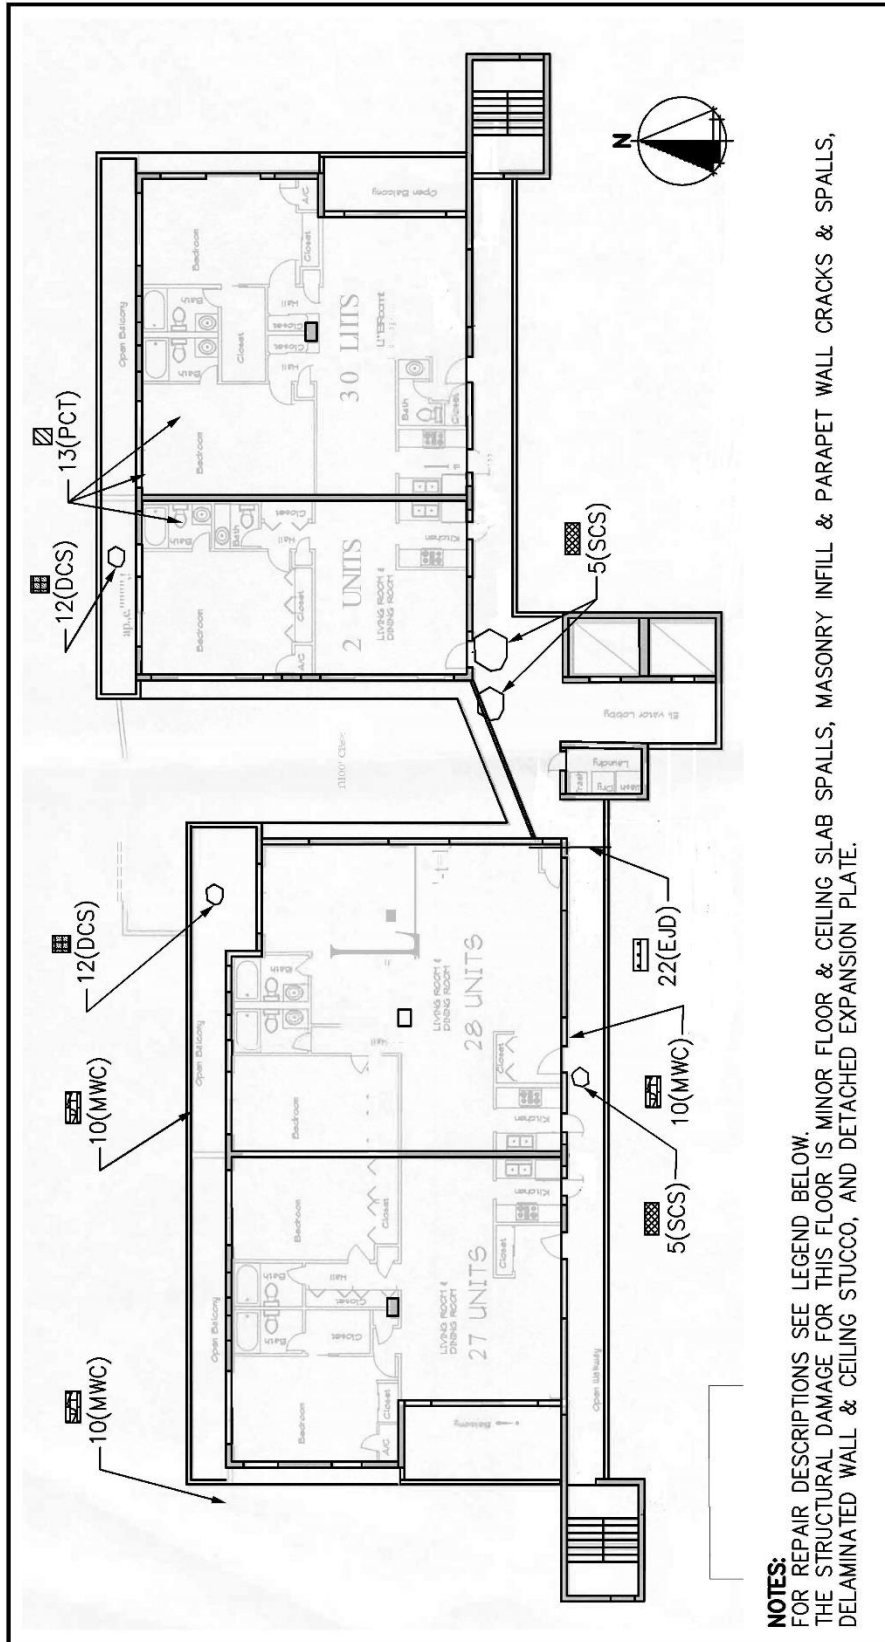
**NOTES:**  
FOR REPAIR DESCRIPTIONS SEE LEGEND BELOW.  
THE STRUCTURAL DAMAGE FOR THIS FLOOR IS MINOR FLOOR & CEILING SLAB SPALLS, MASONRY INFILL & PARAPET WALL CRACKS & SPALLS, DELAMINATED WALL & CEILING STUCCO, AND DETACHED EXPANSION PLATE.

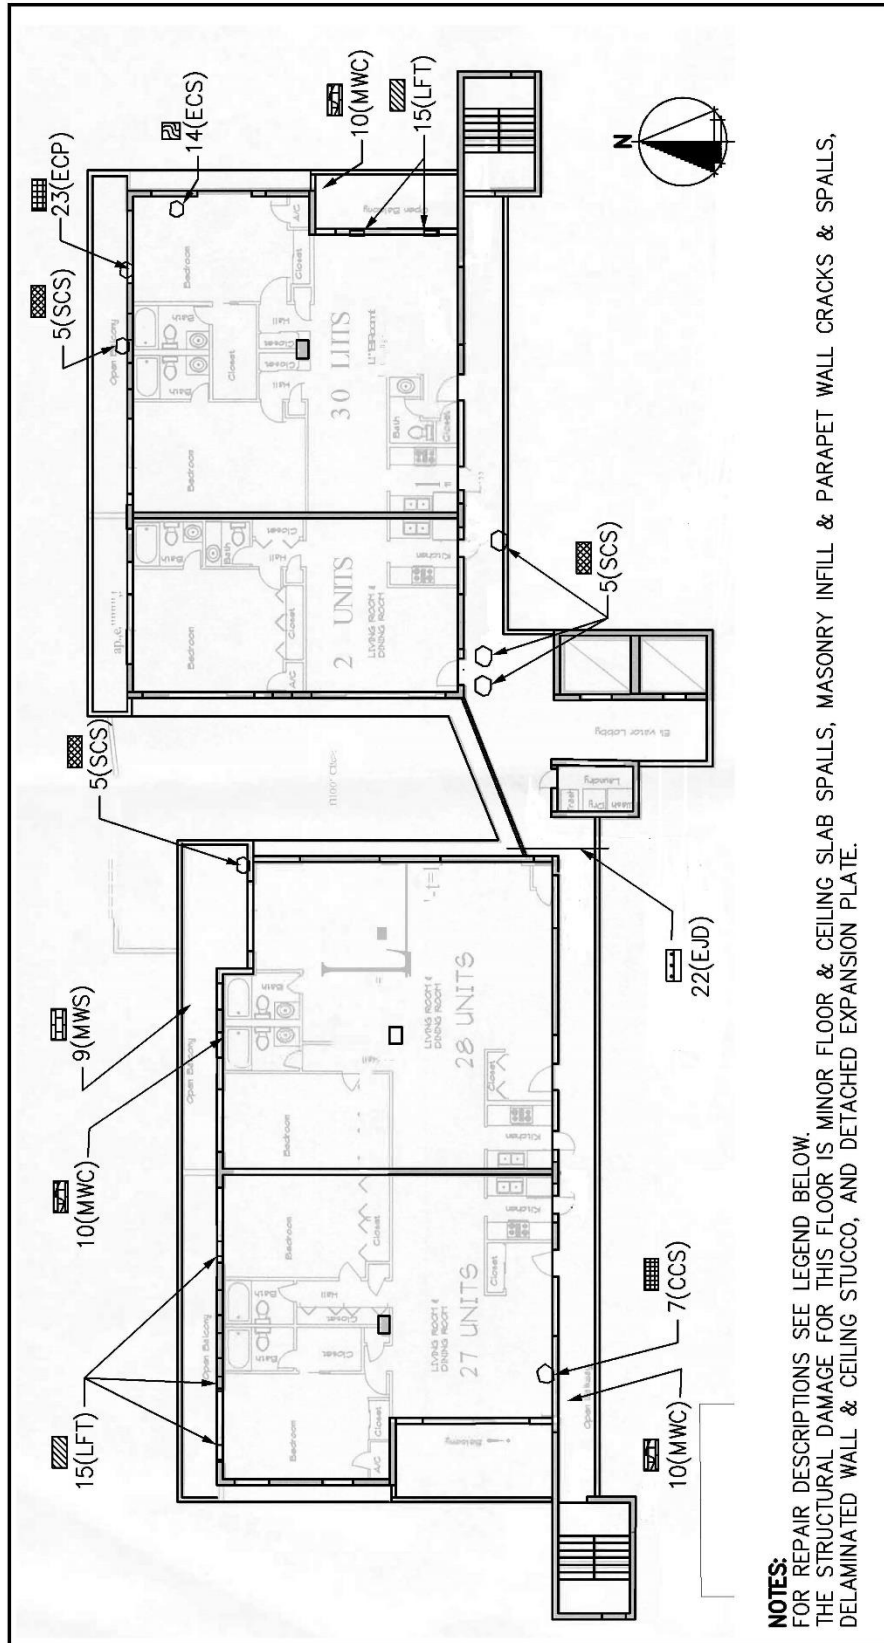
**NOTES:**  
FOR REPAIR DESCRIPTIONS SEE LEGEND BELOW.  
THE STRUCTURAL DAMAGE FOR THIS FLOOR IS MINOR FLOOR & CEILING SLAB SPALLS, MASONRY INFILL & PARAPET WALL CRACKS & SPALLS, DELAMINATED WALL & CEILING STUCCO, AND DETACHED EXPANSION PLATE.

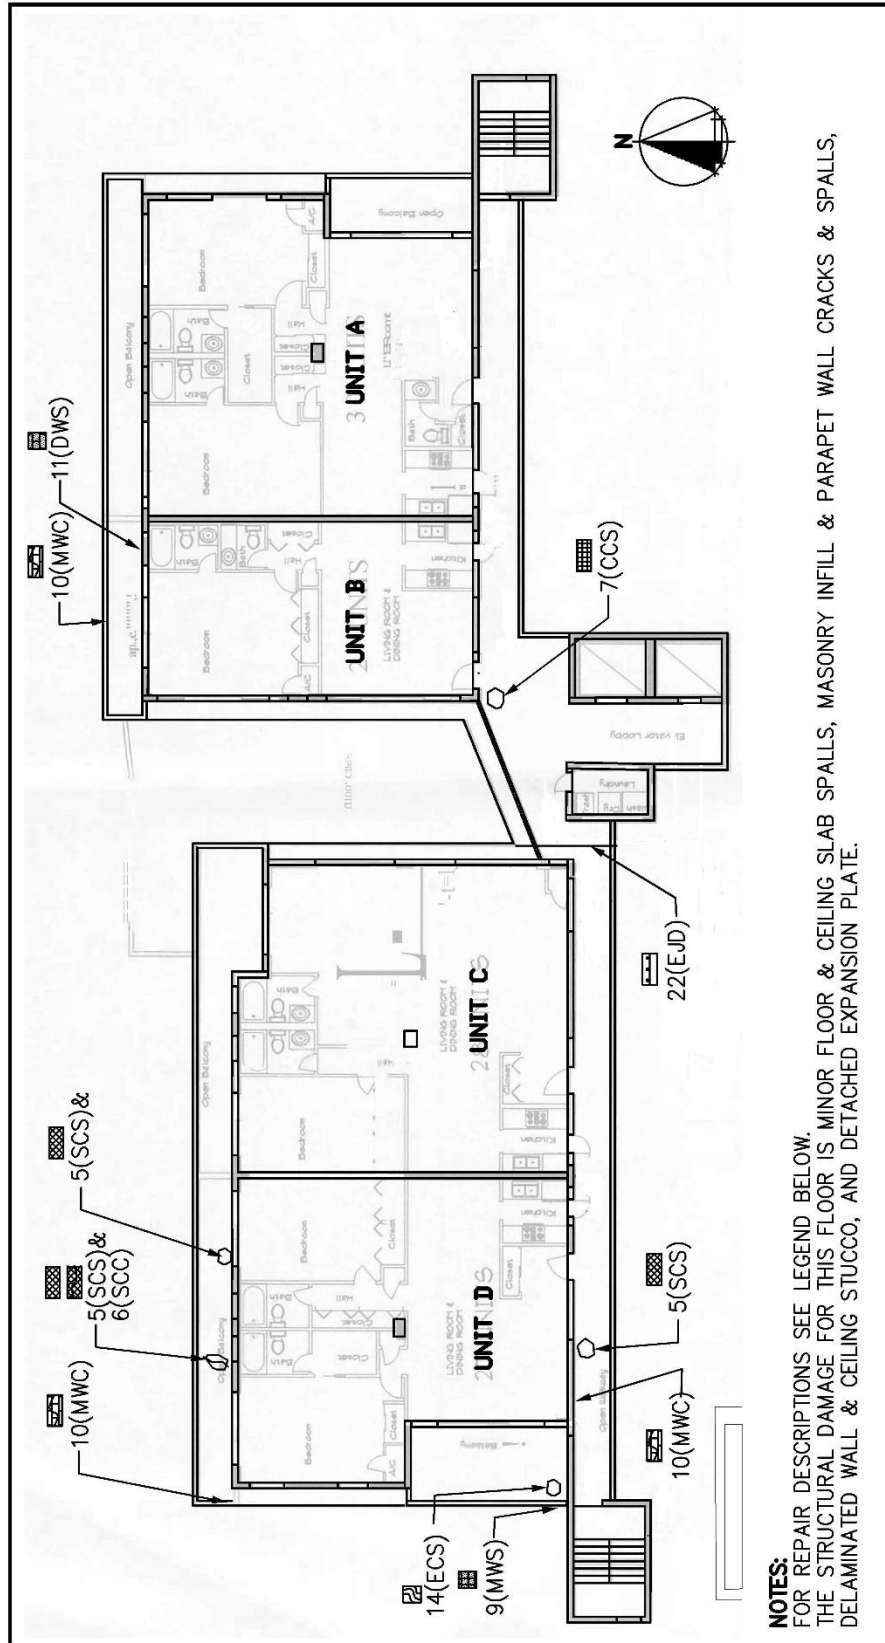
**NOTES:**  
FOR REPAIR DESCRIPTIONS SEE LEGEND BELOW.  
THE STRUCTURAL DAMAGE FOR THIS FLOOR IS MINOR FLOOR & CEILING SLAB SPALLS, MASONRY INFILL & PARAPET WALL CRACKS & SPALLS, DELAMINATED WALL & CEILING STUCCO, AND DETACHED EXPANSION PLATE.
